Investigation of Fire-Damaged Warehouse

A fire occurred in a moving company warehouse in New England in 1998. The owner of the building retained Zallen Engineering to determine the structural safety of the building as a result of the fire and the necessary repairs. The warehouse is 153 feet long by 99 feet wide, was constructed in 1962, and is of metal building construction.

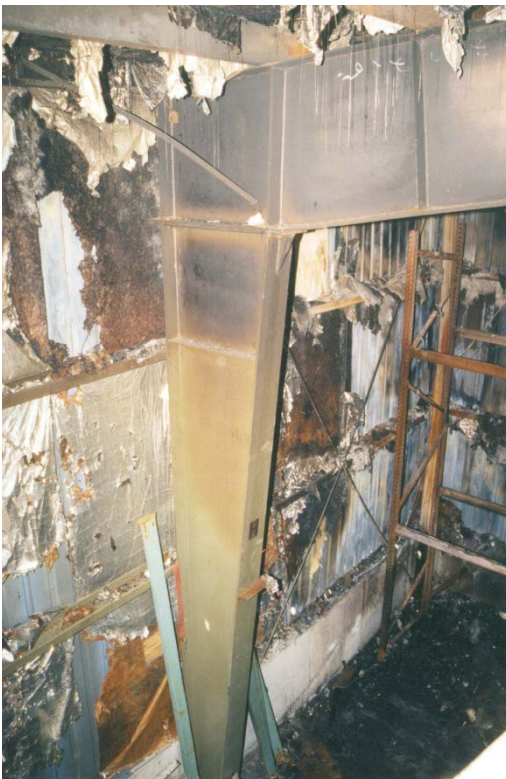
Figure 3. View of rigid frame at grid location A-8.

There were two types of observable fire damage to the structural framing: 1) where the paint was burned off indicating that the members were subject to significant heat from the fire; and 2) where the members were either twisted and kinked. Figures 3 and 4 show paint burned off of the web of a rigid frame. Figure 6 (page 3) shows twisted and kinked roof purlins. Figure 7 (page 4) shows corner A-9, the corner where the fire

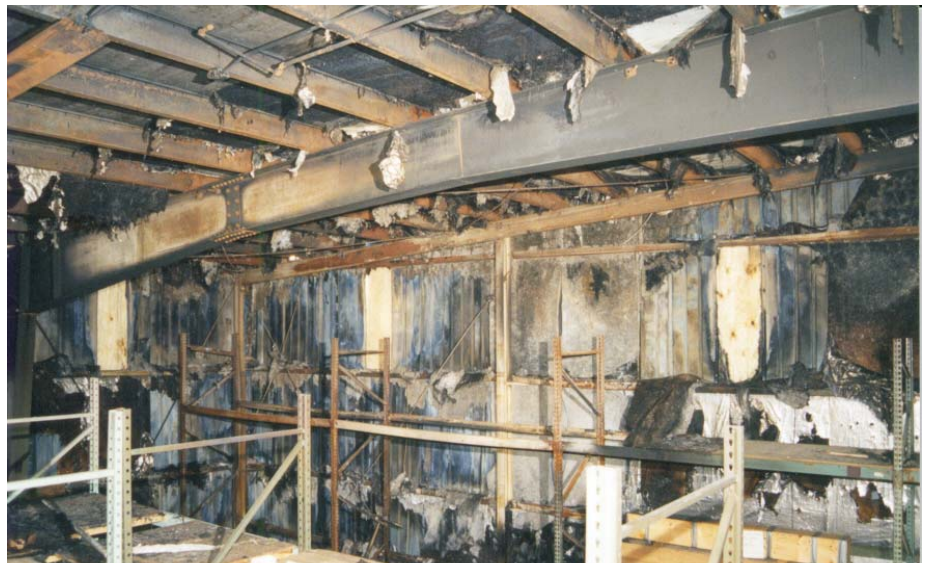
Figure 4. View of rigid frame on Line 8, west of the ridge. In the background is the framing at the end wall on Line 9.

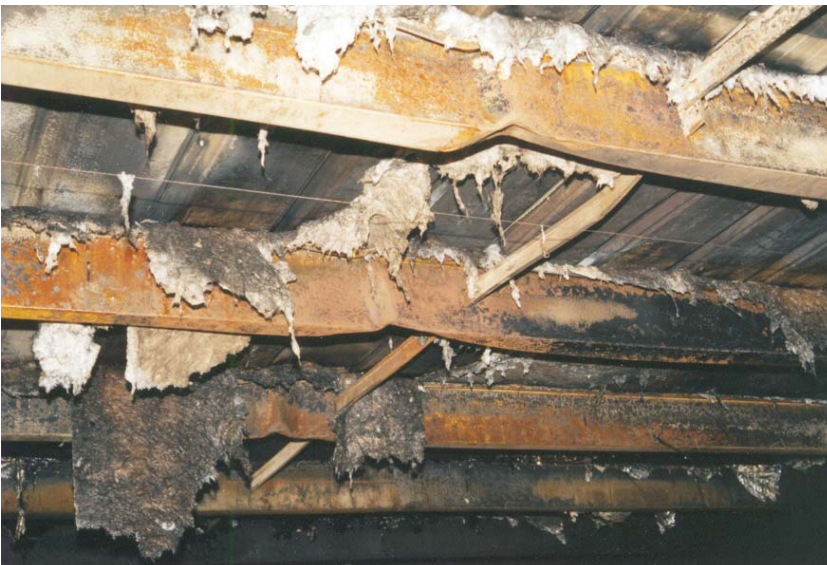
Figure 6. Twisted and kinked roof purlins. Insulation has been destroyed by the fire and the metal roofing is exposed.

The pre-fire snow load capacity of the roof purlins is also 25½ psf for the 20 foot spans (bays between Lines 2 and 8 - see Figure 2). Where the purlins were both twisted and kinked (Figure 6), their estimated snow load capacity is 13 psf, which is substantially below the current building code requirement of 35 psf.

The necessary structural repair work consisted of replacing kinked or twisted purlins and girts, and replacing twisted columns and beams on Line 9. This work necessitated the removal and replacement of the metal roofing, metal siding, and insulation under the roofing and siding, in the affected areas. However, due to the soot on the insulation and other damage to the insulation, all the metal roofing, metal siding, and the insulation under the roofing and siding needed to be removed and replaced, the steel framing power washed to remove the soot, and the structural members repainted.

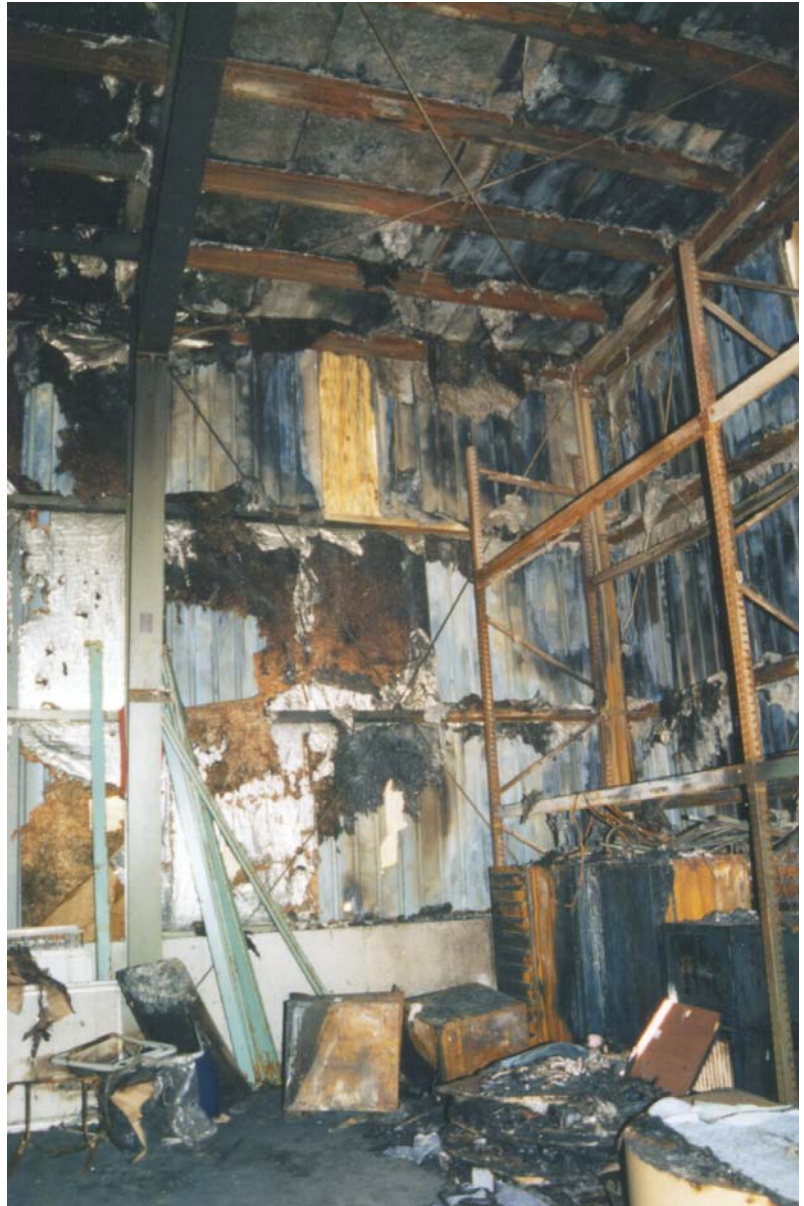
was ignited; the corner column (A-9) is twisted and, although not discernable in the photo, the roof beam on the right (on Line 9) and all the roof purlins and wall girts near the corner are twisted.

Figure 7. Fire damage at corner A-9. Corner column A-9 is twisted; the roof beam on Line 9, framing to this column, is twisted, and the roof purlins and wall girts near this corner are all twisted. Note the rod cross-bracing in the walls and at the bottom of the roof purlins; these are all loose as a result of the fire.
