## Failure of a Rolling Scaffold

Forensic Engineering in Construction® is published by Zallen Engineering, 1101 Worcester Road, Framingham, MA 01701. Comments are welcome. Please direct comments to Rubin M. Zallen, P.E., by telephone at 508-875-1360 or by e-mail at [rmzallen@zallenengineering.com](mailto:rmzallen@zallenengineering.com).

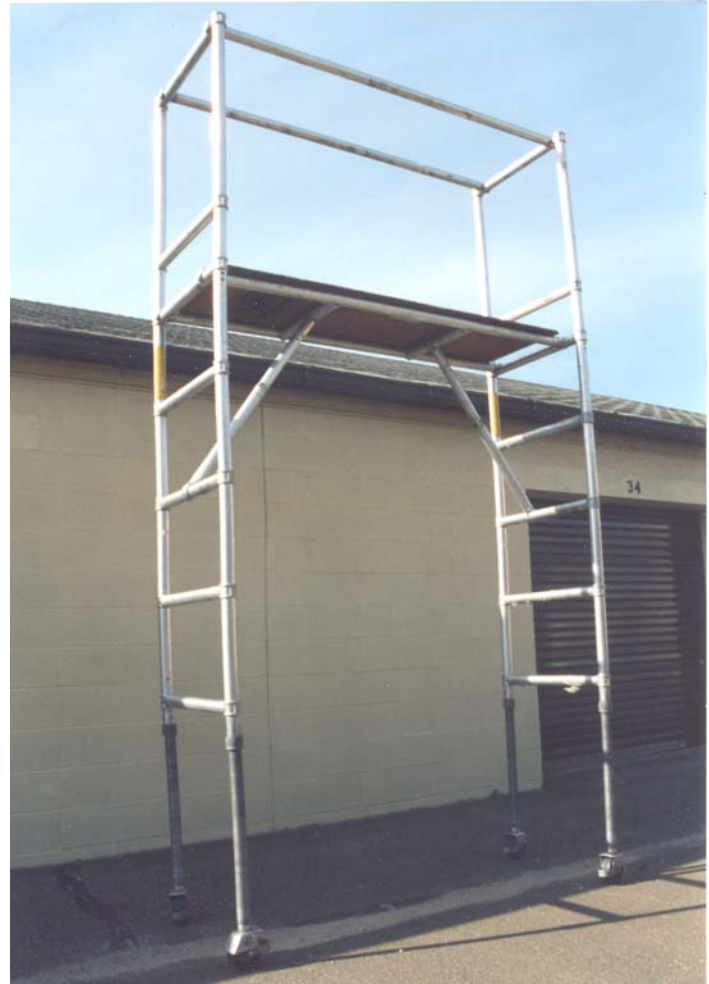
Figure 1 is a photo of the scaffold. It is designed so that it can be readily assembled and disassembled quickly. The framing is thin wall aluminum tubing and the platform is plywood. The legs are adjustable, and the scaffold was used at its maximum height. The wheels have locks and the wheels were locked before use. The width of the scaffold is 2'-2½" and the length is 6'-3½", center to center of the legs. The height of the platform from the floor, as used, was 8'-6". The weight of the scaffold is 108 pounds.

**Figure 1. Lightweight rolling scaffold with adjustable height platform.**

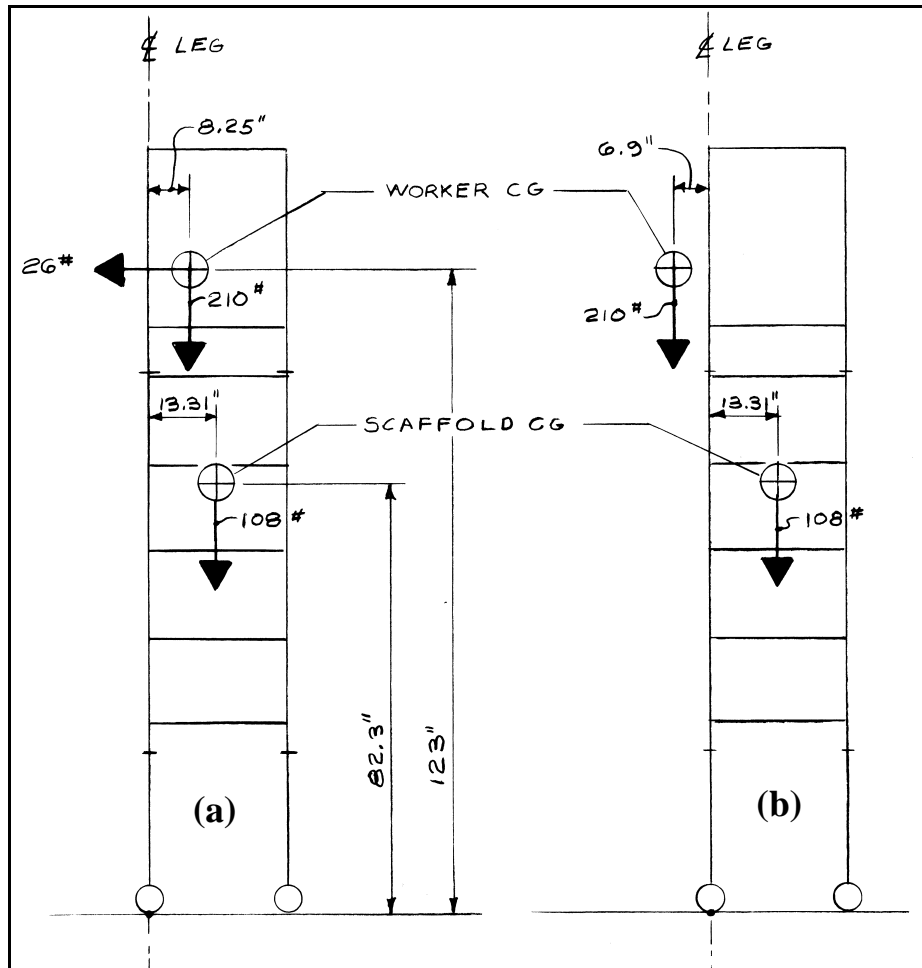
**Figure 2. Schematic view of end of scaffold. (a) scenario where the worker exited the scaffold through the end frame and rotated himself about the leg on the left; (b) scenario where the worker exited the scaffold under the long side railing, while holding onto the railing.**

passed through the opening in the end frame, and as he did so, rotated himself around the leg he had grabbed. He further testified that as he was rotating, the scaffold tipped over. A maintenance man for the department store testified, on the other hand, that the injured worker exited the scaffold by ducking under the long side railing and attempted to step onto the step ladder while holding on to the railing, at which time the scaffold tipped over. Figure 2 is a schematic end view of the scaffold showing the forces on the scaffold for the two scenarios, just at the point where the scaffold would start to tip over. Figure 2a is for the scenario of the worker exiting through the end frame;

Figure 2b is for the scenario of the worker exiting under the long side railing. In the first scenario, only a lateral force slightly more than 26# would be required to tip the scaffold; in the second scenario, the worker would only need to be slightly more than 6.9 inches beyond the centerline of the legs to tip the scaffold. With regard to the first scenario, the 26 pound lateral force could be readily attained by the worker moving at 1 to 2 feet per second and stopping short as he completed his rotation. The 1 to 2 feet per second is very slow; 4 feet per second is slow walking. Thus for both scenarios, the scaffold was dangerous and prone to tipping. *(Continued on Page 3)*

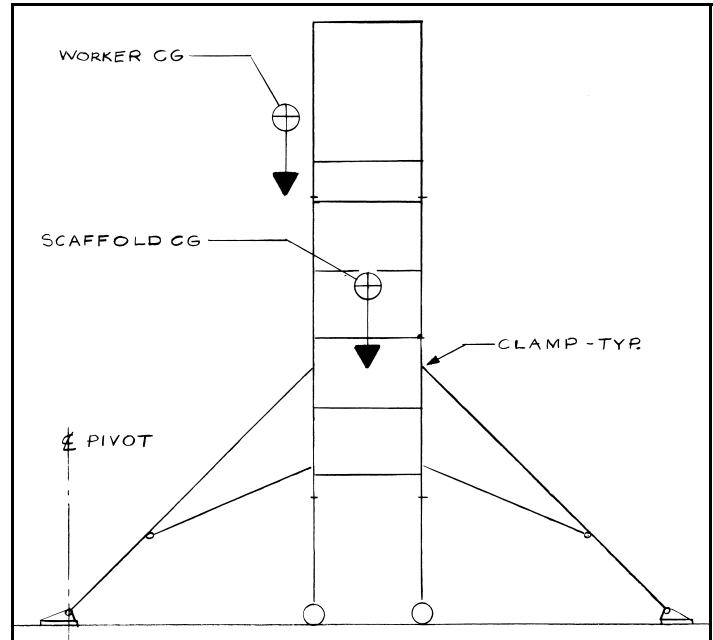
**Figure 3. Schematic view of end of scaffold with outriggers.**

The department store knew that the scaffold was prone to tipping, but did not inform the maintenance contractor or his laborers of this fact. As the above mentioned maintenance worker testified, the department store's "safety" rule for using the scaffold was that a second person had to hold the scaffold from tipping when someone was on the scaffold. Further, the department store ignored the instructions that were posted on two of the legs of the scaffold: that outriggers are required when the height of the platform is more than three times the width of the scaffold. Figure 3 shows a schematic end view of the scaffold with outriggers; the loading shown is that of the second scenario. The outriggers are on each end frame; the wide base created by the outriggers prevents the scaffold from tipping. However, regardless of height, the scaffold is prone to tipping when a worker enters or exits the scaffold from under the long side railing; thus some form of outrigger should be used at all times.
