Collapse of Underground Storm Water Detention System

Forensic Engineering in Construction® is published by Zallen Engineering, 1101 Worcester Road, Framingham, MA 01701. Comments are welcome. Please direct comments to Rubin M. Zallen, P. E., by telephone at 508-875-1360 or by e-mail at rmzallen@zallenengineering.com.

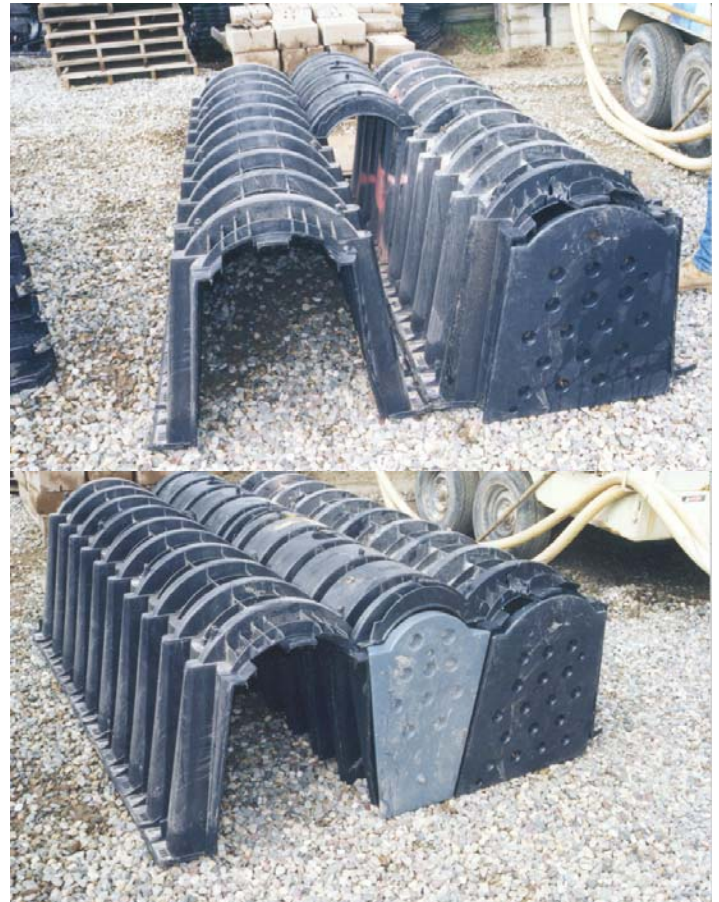
Figure 1 shows the components of the system that failed. They are made from injection molded high-density polyethylene (HDPE). The main chambers are composed of an arch with inclined legs and are 7'-3" long. The inclined legs are each on a base which is set on top of a crushed stone base course, toe to toe with the adjacent main chamber. The top of the spaces between the main chambers are covered with arched fillers. The main chambers are butted end to end to form a row. The ends of the rows are covered as shown in Figure 1, with covers for the main chambers and different covers for the spaces between the main chambers.

Figure 1. Storm water detention system components as assembled.

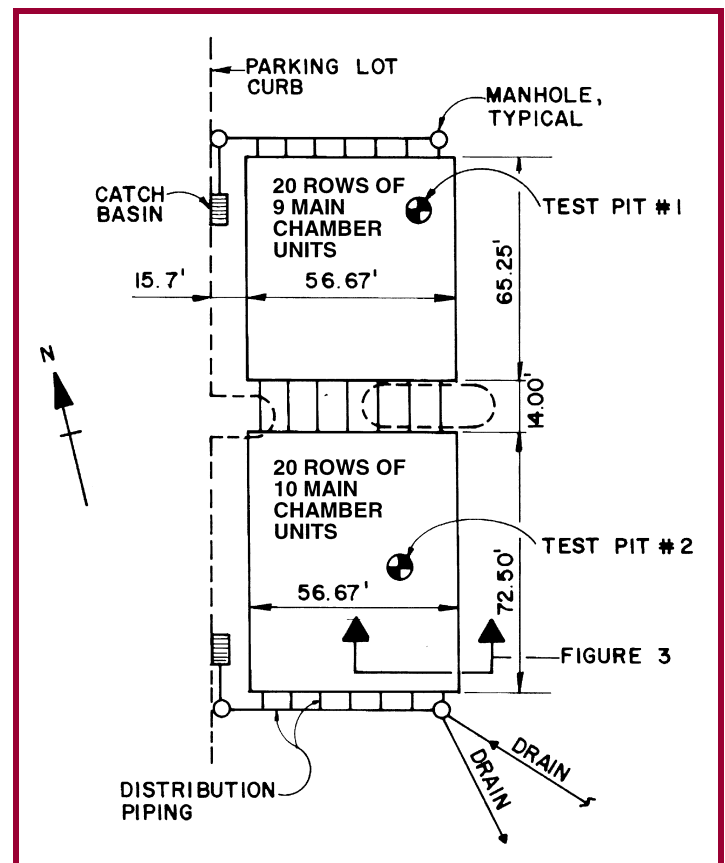
Figure 2 (*page 2*) shows a plan of the storm water detention system that failed. It is located in a suburban mall in Massachusetts. Figure 3 shows a section through the storm water detention system, taken as shown on Figure 2. As shown on Figure 3, crushed stone and filter fabric were placed between the sides of the system and the edge of the excavation. Crushed stone and filter fabric were also placed between the end covers and the edge of the excavation, similar to the detail at the sides of the system. The top of the sys-

Figure 2. Plan of storm water detention system.

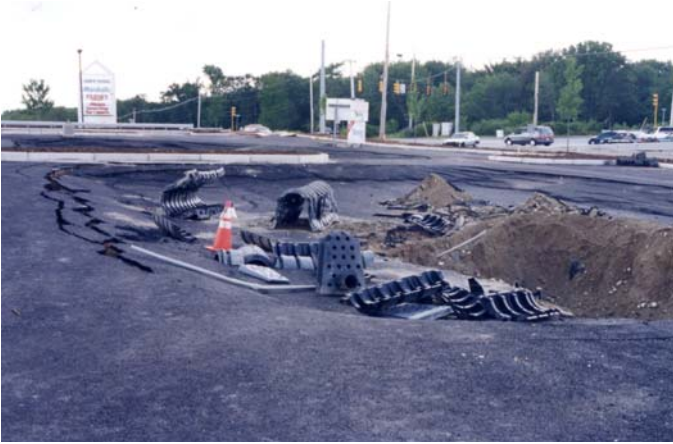
The subject storm water detention system was constructed in the middle of July 1997 and collapsed on August 31, 1997. Figures 4 and 5 (*page 3*) show the collapse of the northerly field of the storm water detention system. The collapsed southerly field can be seen in the background of Figure 4.

Figure 4. East side of collapse of northerly field, looking south. The collapsed southerly field is in the background.

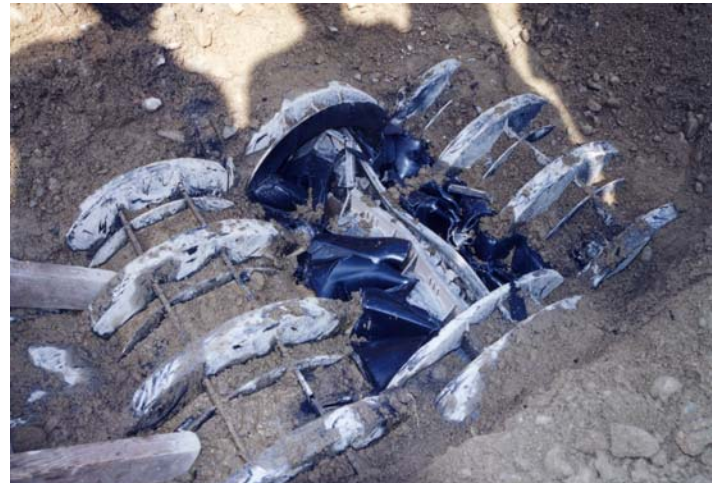
Figure 6 (page 3) is a photo from Test Pit No. 2 (see Figure 2 for location). The legs of the main chamber units buckled and were squashed such that the paving above dropped 24 inches.

Figure 6. Test Pit No. 2 showing the top of a main chamber removed. The buckled legs of the main chamber are partially visible, and extend under the top arch fillers on each side.

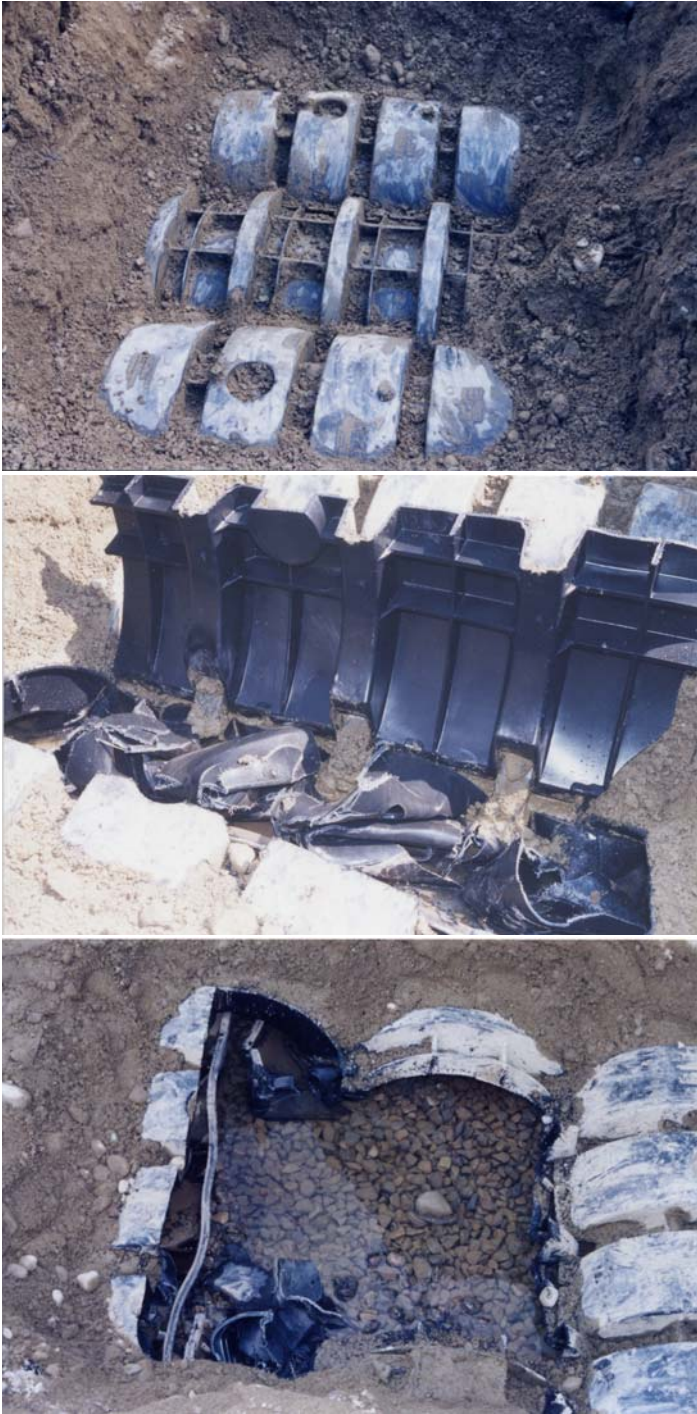
Figure 7 (page 4) shows photos from Test Pit No. 1. The same as observed in Test Pit No. 2, the legs of the main chamber buckled and the whole system dropped down 24 inches to the top of the crushed stone base.

Figure 7. Test Pit No. 1. Top photo: center arch is top of a main chamber; adjacent arches are fillers over the spaces between main chambers. Center photo: near side arch filler cut away revealing collapsed legs of main chambers. Bottom photo: after removal of main chamber arch and near side arch filler. All arches are resting on the crushed stone base, 24" below their original positions.

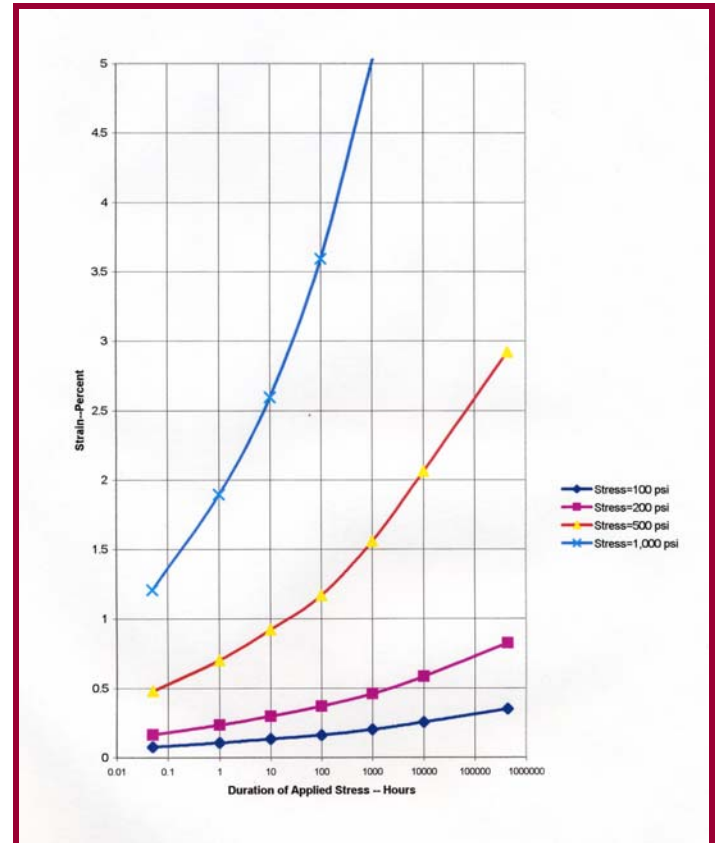
Plastics, in general, and HDPE in particular, are viscoelastic, which means that the material keeps deforming under sustained load. This behavior is also called *creep*. Figure 9, adapted from Jansen (1989)¹ shows typical values of this behavior for various levels of stress for tensile test specimens. In the figure, the term *strain* is the change in length divided by the original length. Note that each division on the horizontal time axis is a change in magnitude by a factor of 10.²

Figure 9. Strain versus time at various levels of sustained stress (adapted from Janson).

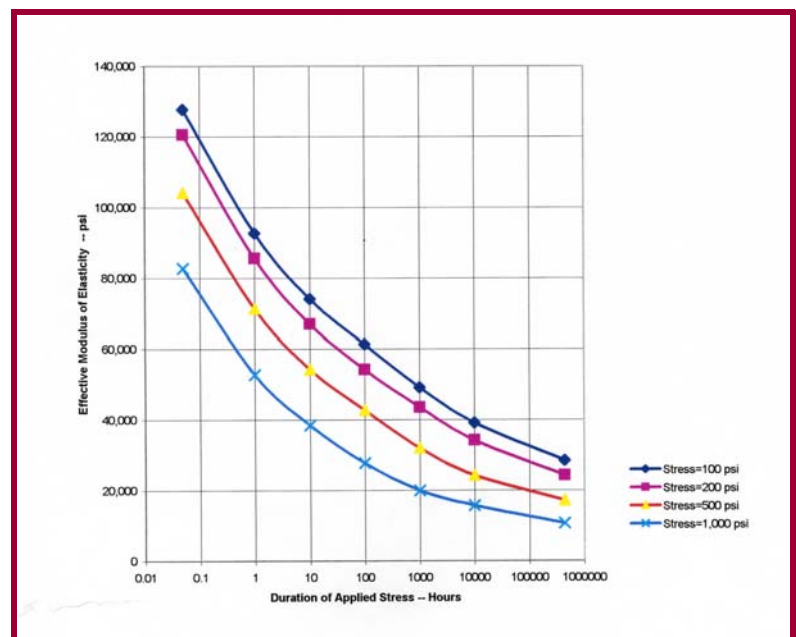
counts for the creep, which is called here the *effective modulus of elasticity*. Due to increasing deformations under sustained load, the effective modulus of elasticity of HDPE is reduced dramatically with time. Typical values of the effective modulus of elasticity are plotted versus time in Figure 10, as adapted from Janson (1989).¹ This figure demonstrates that the decrease in effective stiffness of the HDPE under sustained load, due to creep, is dramatic.

The stress in the main chamber legs due to the weight of the long term superimposed load (i.e. the paving and compacted gravel), as shown on Figure 3, varied from 270 psi to 420 psi. As shown on Figure 10, the effective Modulus of Elasticity for an axial loaded member with a sustained stress midway between 200 and 500 psi at one hour is 80,000 psi, but after 1000 hours (42 days) the effective Modulus of Elasticity will drop to 38,000 psi, and after 100,000 hours (11 years) it will drop to 24,000 psi. These values may be low for the subject HDPE, but the trends will be similar for a higher strength HDPE; i.e. the original Modulus of Elasticity will be reduced to approximately 50% after 1000 hours and 30% after 100,000 hours.

Figure 10. Effective modulus of elasticity versus time for HDPE at various levels of sustained stress (adapted from Janson).

38 and 48 inches. The estimated modulus of elasticity at 1 hour of sustained load is 110,000 (AASHTO, 1991).⁴ Calculations based on this modulus indicate that the legs of the main chamber unit would not buckle. When the legs of the main chamber units collapsed, the compacted gravel backfill had been in place approximately 1½ months or 1100 hours. As the trends of Figure 10 show, the effective modulus of elasticity would be reduced by approximately 50% in that time, and calculations indicate that the legs of the main chamber unit would buckle under this reduced modulus.

The cause of the collapse was that the manufacturer did not understand the creep characteristic of the viscoelastic HDPE material used

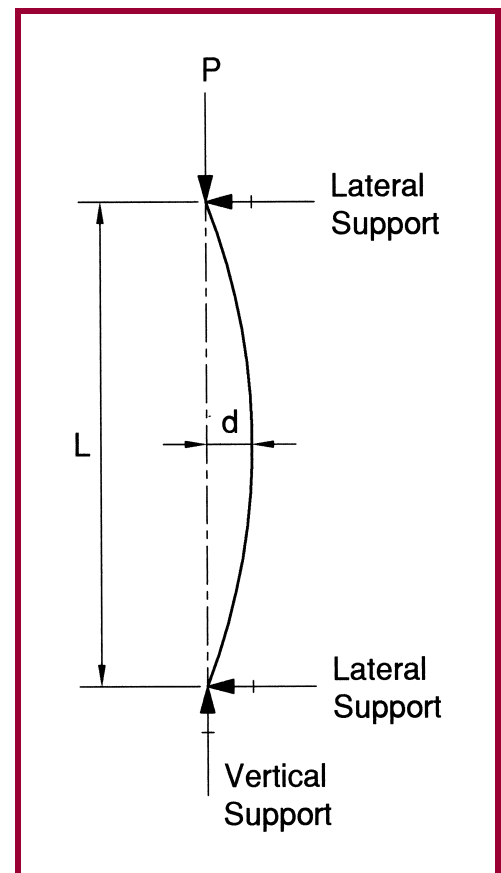
Figure 11 (*page 6*) depicts a structural member in compression such as a column. P is the load on the column, L is the length of the column, and d is a small imperfection (exaggerated in the figure). If the member was ideally elastic and straight, d would be zero. The critical load, P_{CR} , the load at which the ideal column buckles is:

Figure 11. Axial compression member.
