## Investigation of a Steel Pony Truss Bridge

The investigation of one of these bridges, the Main Street Bridge over the Sudbury River is described in this issue.

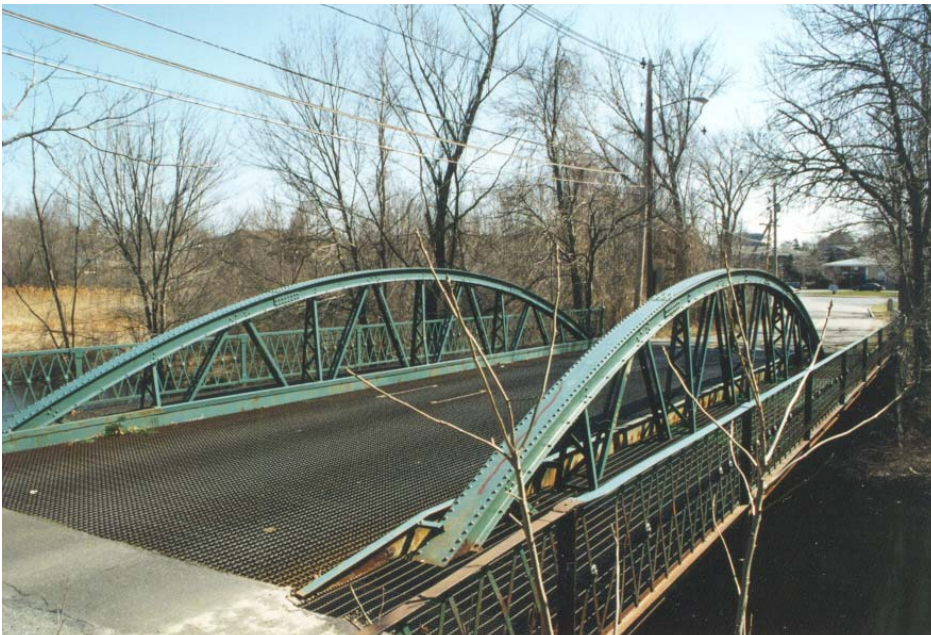
**Figure 1. The Main Street Bridge, circa 1995.**

Figure 1 shows the Main Street Bridge as it existed in 1995. This bridge is an example of an early steel bridge probably built between 1890 and 1900. It has a 71 foot span with the main members being what is commonly called *half through trusses* or *pony trusses*. It was originally built with a timber deck supported by timber stringers (longitudinal beams), both of which were replaced in 1946 by an open steel grate deck and steel I-beam stringers.

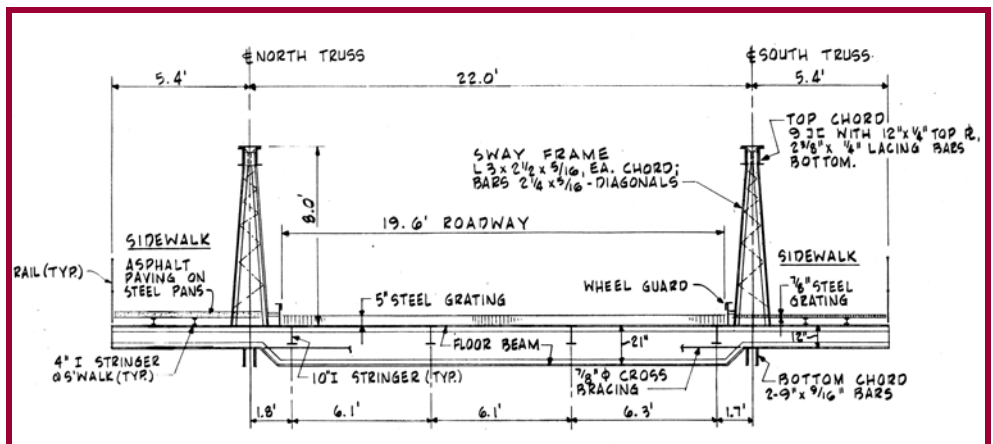
Figure 4. Transverse section through Main Street Bridge.

The arch shaped top chords of the trusses are in compression and thus have a tendency to buckle transverse to the planes of the trusses, i.e. displace laterally. (They also have a tendency to buckle vertically but this effect is readily resisted by the other members of the trusses which are connected to the top chords). The transverse buckling is resisted by *sway frames* which can be seen in Figure 1 and which are shown on Figures 3 and 4. Referring to the bridge cross-section on Figure 4, if the top chords try to buckle transverse to their own planes, this tendency would be resisted by the bending resistance of the sway frames, acting as vertical cantilevers (in the plane of Figure 4). The sway frames are at-

The bridge capacity was determined to be 2½ tons for Type H and Type 3 trucks in accordance with the AASHTO guidelines.<sup>3</sup> The "weak link" for load capacity turned out to be the bottom chords. These chords (see Figure 4) are tension members made out of two flat bars.

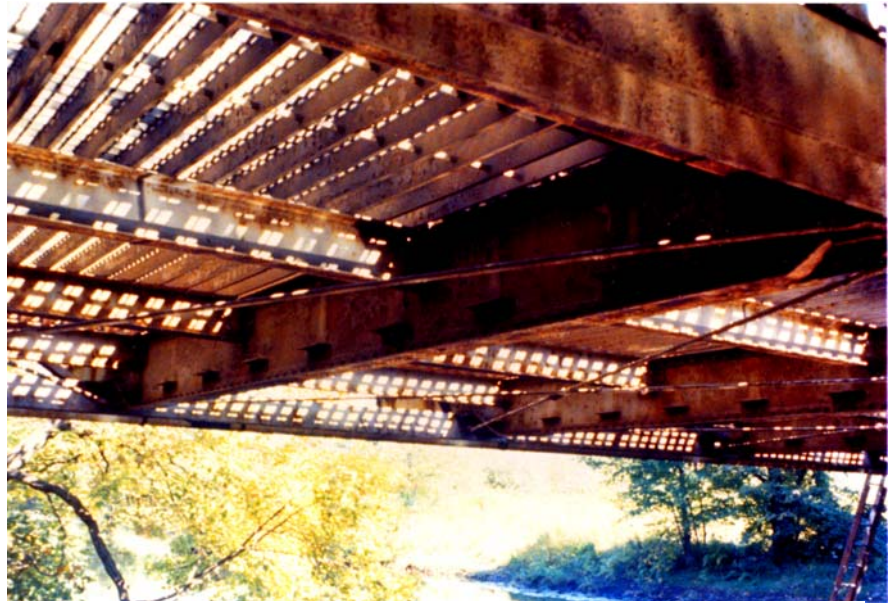
Figure 5 shows the angle seats on the floor beams that supported the original timber stringers (up to 1946). The horizontal rod cross-bracing near the bottom of the transverse floor beams can also be seen.

**Figure 5. View of bottom of Main Street Bridge, circa 1978, showing seats on the floor beams for the original timber stringers.**
