## Preventing Collapse of a Manufacturing Building Being Converted to Housing Use

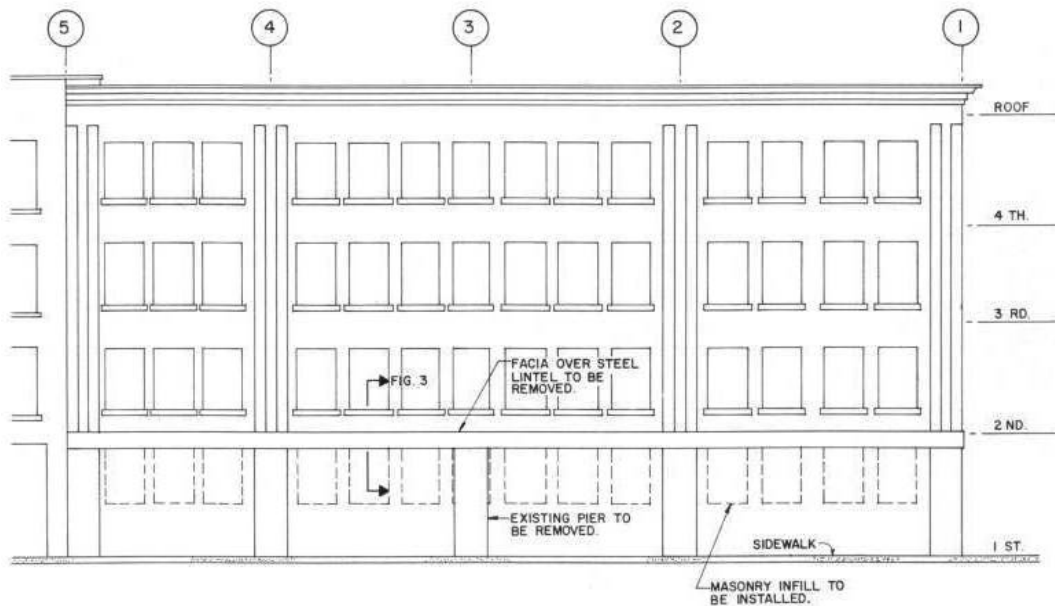
**Figure 1 Schematic elevation of southerly half of wall on Line G, where collapse was prevented, showing original conditions.**

The exterior walls and the party walls are brick masonry bearing walls, supported on concrete foundation walls. The original floor construction consists of a 3 inch tongue and groove plank deck supported typically by 10" x 12" wood beams at approximately 8 feet on center, which in turn are supported by steel "I" beam girders. The "I" beam girders are supported by timber columns and by the brick bearing walls. Originally, there was store front construction at the first story, along Lines A, 1, and G, with steel beam lintels spanning over the store front windows and supporting the brick bearing walls above. Figure 1 is an elevation of the southerly structure along Line G, showing the original store fronts.

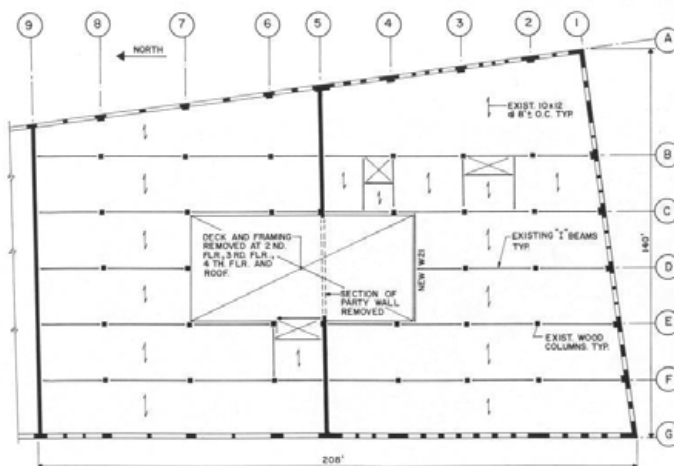
**Figure 2 Schematic plan of manufacturing building converted to urban housing, showing typical framing.**

Figure 2 shows a schematic floor framing plan of the building, as it was converted. The building was originally

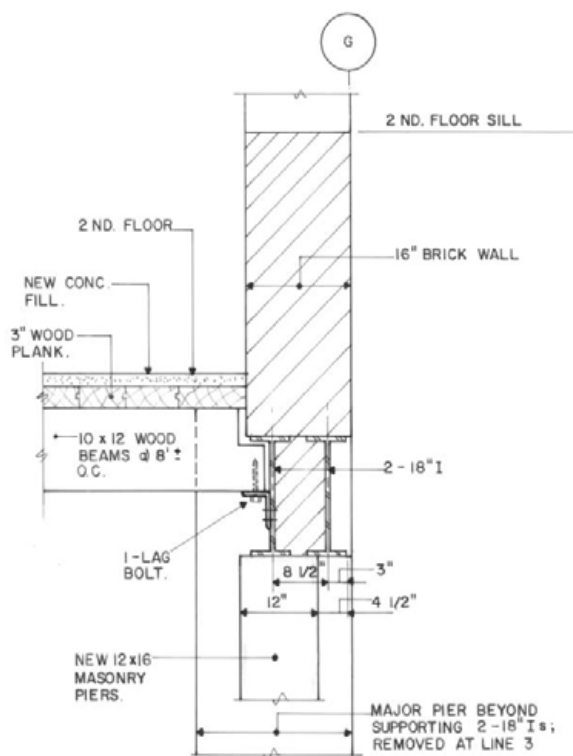
**Figure 3 Section through lintel construction on Line G.**

Figure 3 is a section through the lintel and the 2nd floor on Line G, between Lines 1 and 5. Shown is the actual lintel construction of 2-18 inch deep "I" beams which support the masonry above. These "I" beams originally spanned between the major masonry piers that divide the store front windows. As part of the renovation, new masonry piers, as shown on Figure 3, were added on Line G between the foundation wall and the bottom of the lintel (as part of the masonry infill). The major support pier at Line 3 was removed after the installation of these new piers. The new piers were constructed from 8"x16" hollow concrete chimney block with 4" brick on the outside face.

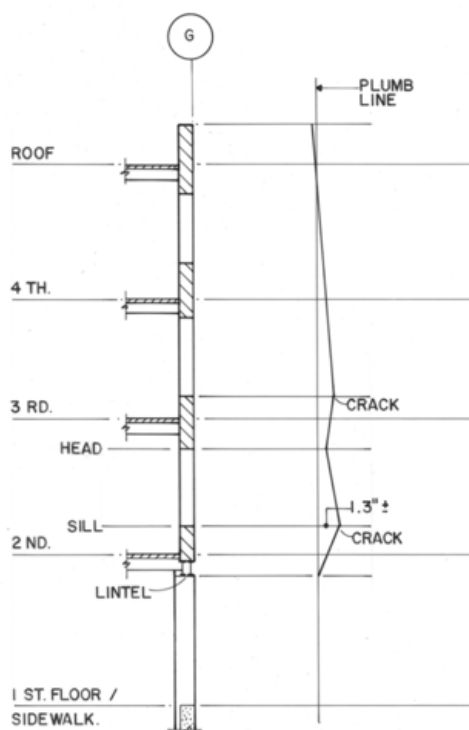
**Figure 4 Lateral displacements of wall on Line G.**

The investigation by Zallen Associates revealed that not only had the wall moved outward, but that the wall had dragged part of the 2nd, 3rd, and 4th floors outward, as well. Figure 4 shows the wall displacements. The cause of the lateral movements of the wall is that the outer 18 inch "I" beam had no stable support after the pier on Line C was removed. The new masonry piers on Line G, although numerous, were eccentric from, and inside of, the center of the outer "I" beam, causing the outer "I" beam to roll outward, which in turn caused the wall above to move outward.

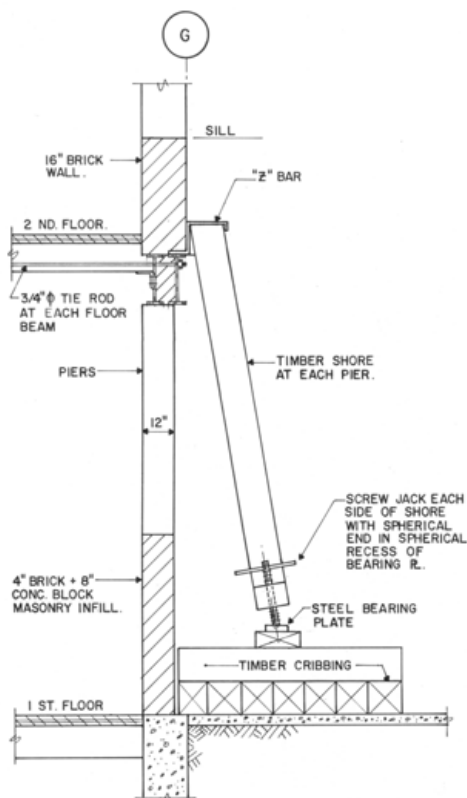
**Figure 5 Shoring scheme showing inclined shores and tie rods at the wall on Line G.**

In order to prevent further movement of the wall on Line G, two measures were taken: 1) Inclined timber shores were installed to support the wall just above the lintel beams, between Lines 1 and 5, as shown on Figure 5. These shores were located opposite each pier, and were supported on timber cribbing on the sidewalk. A special "Z" bar cap on each shore was cut into the masonry. The screw jacks at the bottom of the shores were made snug, but no jacking

The next step in the process was to install permanent 3/4" diameter tie rods and turnbuckles at each floor beam at the 2nd, 3rd, and 4th floors, between Lines 1 and 5, as shown on Figures 5 and 6. These rods extend from the Line G wall, through holes made in the webs of the steel girders, to the Line A wall, except that where the rods are interrupted by the court, they were terminated on Line E, and corresponding rods were run from Line C (on the other side of the court) to Line A. Also at this time, vertical shores with jacks were installed from the foundation wall on Line G to the bottoms of the double 18 inch "I" beam lintels where they terminate near Line 3 (where the pier had been removed).

To restore the wall to its original position, the screw jacks of the inclined shores were tightened to lift the wall, and simultaneously the 3/4" diameter tie rods were tightened to pull the wall inward. Also, the temporary cables attaching the 6"x8" timbers to the Line E columns were simultaneously kept tight. As the wall was lifted, the shores under the lintel beams at Line 3 were jacked to bring the lintel beams back into their original position. When the walls and lintel beams were restored to their original positions, the 12"x16" piers were removed, and 16"x16" solid brick piers, concentric with the pair of lintel beams, were installed. The last step was to repoint the brick wall and to remove the shoring and other temporary supports.

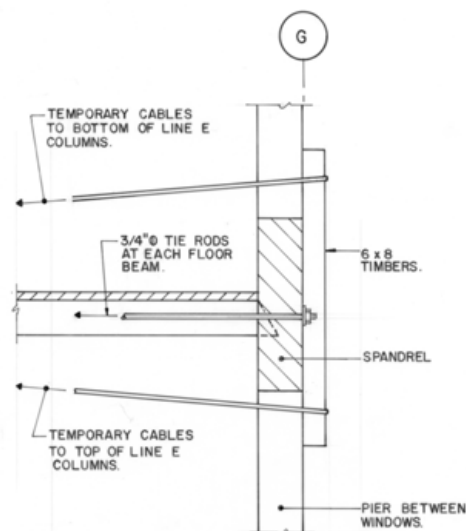
**Figure 6 Shoring scheme showing tie rods, and showing temporary timbers and cables used to laterally stabilize the masonry wall.**

2) The 2nd, 3rd, and 4th floor brick spandrels on Line G, between Lines 1 and 5, were tied back into the building as shown in Figure 6. Temporary 6"x8" vertical timbers were placed against the

outside of the spandrels, and the timbers were tied through the window openings by temporary cables to the tops and bottoms of the Line E columns.
