Collapse of Flying Formwork During Concrete Placement

Forensic Engineering in Construction® is published by Zallen Engineering, 1101 Worcester Road, Framingham, MA 01701. Comments are welcome. Please direct comments to Rubin M. Zallen, P.E., by telephone at 508-875-1360 or by e-mail at rmzallen@zallenengineering.com.

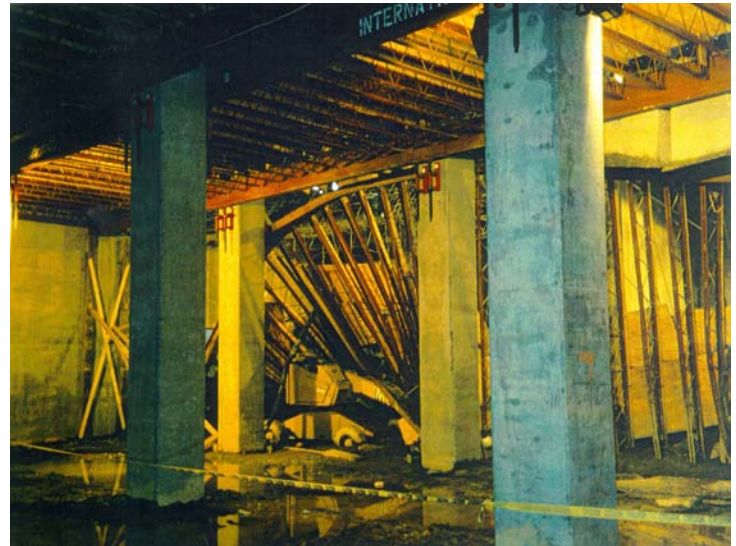
Figure 1. View of collapse from below. Photo taken from under flying formwork that did not collapse.

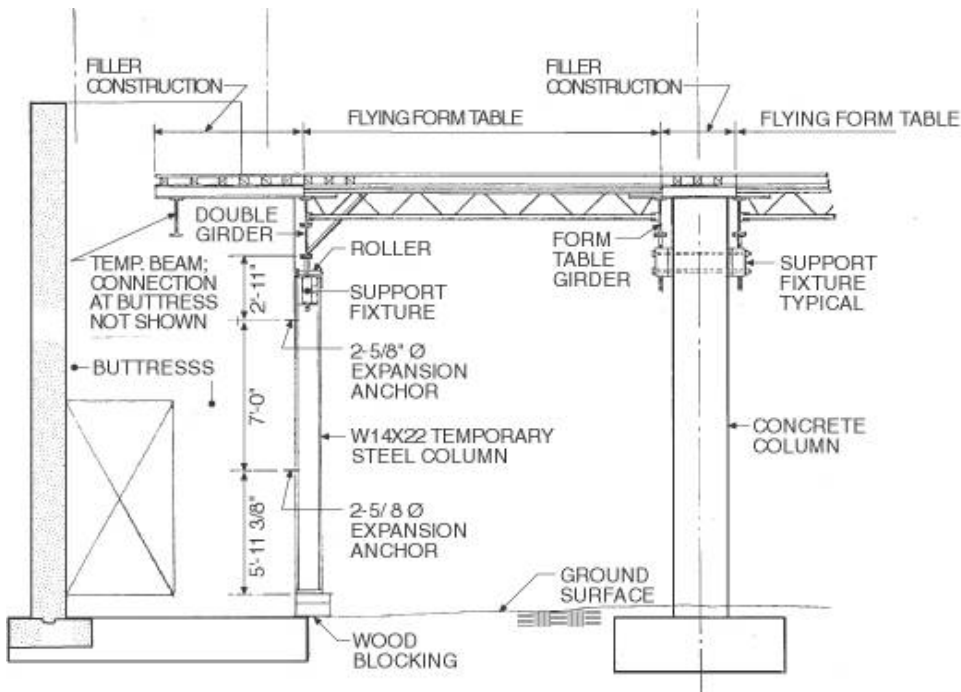
Figure 4. Section through formwork for waffle floor, taken at the same location as Figure 3. Waffle pan forms and side forms are not shown.

Figure 4 shows details of the temporary steel columns at the ends of the buttresses, at the time of the collapse. The formwork erection drawings showed no detail for the support of the base plate of the steel columns adjoining the buttresses; they just indicated that the bottom of the base plate would be at the level of

The flange of the temporary steel columns adjoining the ends of the buttresses was attached to the buttresses with two pair of 5/8 inch diameter expansion anchors. See Figures 4 and 8. One purpose of these anchors was to hold the column and the supported formwork in-place; a second purpose was to provide lateral support to the column so as to prevent lateral buckling of the column perpendicular to the web of the column.^{1,2}

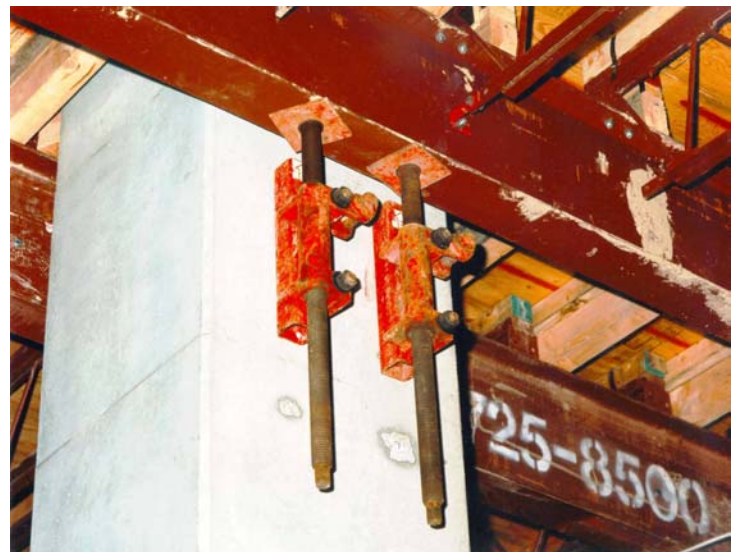
Figure 6. Support fixtures for flying forms.

The length of each table (and its girders) was 40 feet and the width was set to clear the concrete columns or the ends of the buttresses. The girders of the table thus spanned over three supports, with each end of the girders being simply supported on a single screw jack, and the center of the girders being supported on two screw jacks (see Figure 6).

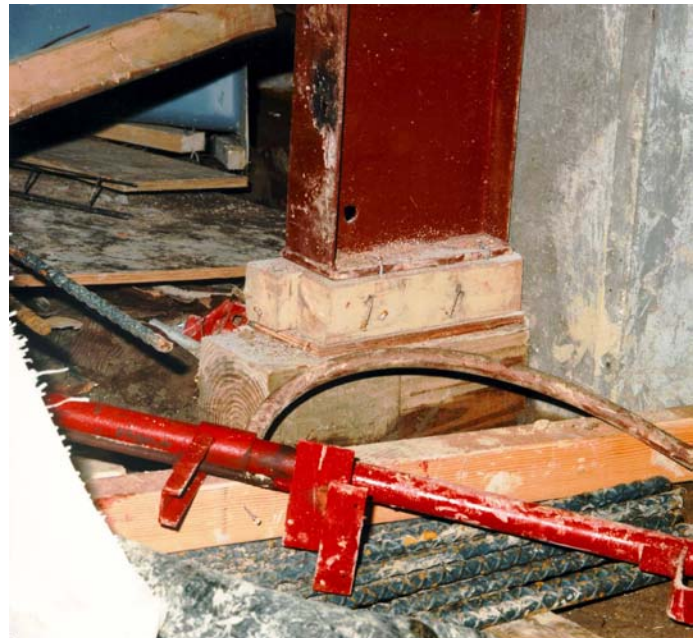
the top of the ground floor slab on grade. (The slab would be installed at a later time). The wood blocking supporting the column base plate was added in the field by the concrete subcontractor. See Figure 7.

Figure 7. Wood blocking supporting base plate of temporary steel column on Line 5; believed to be at the most northerly end of the formwork that collapsed. (The column shown did not collapse).

When the load from the concrete was imposed onto the steel columns adjoining the buttresses, the columns pushed down on and compressed the wood blocks, and at the same time loaded the expansion anchors in shear. A basic structural principle is that when load is shared between various elements, it will be transferred to the elements in proportion to their respective stiffnesses; the stiffer the element, the greater the percentage of load it will support. Relative to the steel column itself and to the expansion anchors, the wood blocking in compression is flexible, thus a substantial portion of the column load was transferred to the expansion bolts. Since the reaction (the resisting force) of the expansion bolts on the column is eccentric to (i.e., not in line with) the load on the top of the column, the top pair of expansion anchors were subjected to tension in addition to the shear on these anchors.³

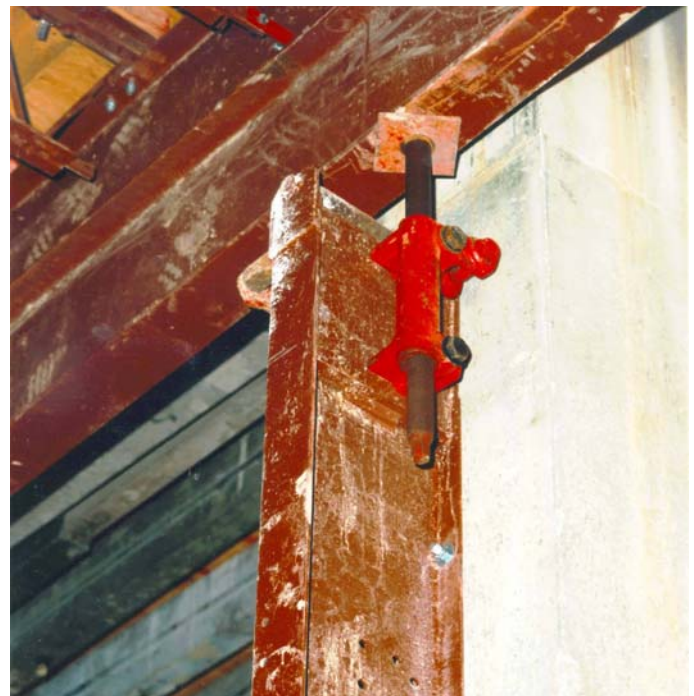
Figure 8. Top of temporary steel column showing one of the top pair of 5/8 inch diameter expansion bolts.

The failure was initiated at the temporary steel column at grid location W-5, which was one of the two most heavily loaded temporary columns, when the top pair of expansion bolts pulled out of the concrete in a concrete cone mode of failure, and the bottom pair of bolts sheared off. The vertical load was then completely transferred to the wood blocks; however, at the same time the column buckled laterally and collapsed, since, with the failure of the expansion anchors, it lost its intermediate lateral support. The failure of Column W-5 precipitating the collapse of the whole bay with most of the other temporary columns failing in a similar mode. The estimated load on the column when it failed was 90,000 lbs. The calculated ultimate capacity of the column with one flange braced laterally by the expansion anchors is 118,000 lbs. However, the calculated ultimate capacity without that flange being braced is only 40,000 lbs.
