Collapse of 112 Foot Long Deep Longspan Steel Joists

Deep longspan steel joists with a span of 112 feet collapsed during the construction of a large middle school complex in New England in 1996. See Figure 1. The complex consists of many independent structures linked together to form an “L.” At one end of the “L,” there is a high bay library building. Figure 2 (on page 2) is a framing plan of part of the library building. The building is 113 feet wide and 120 feet deep. The roof height is 28 feet.

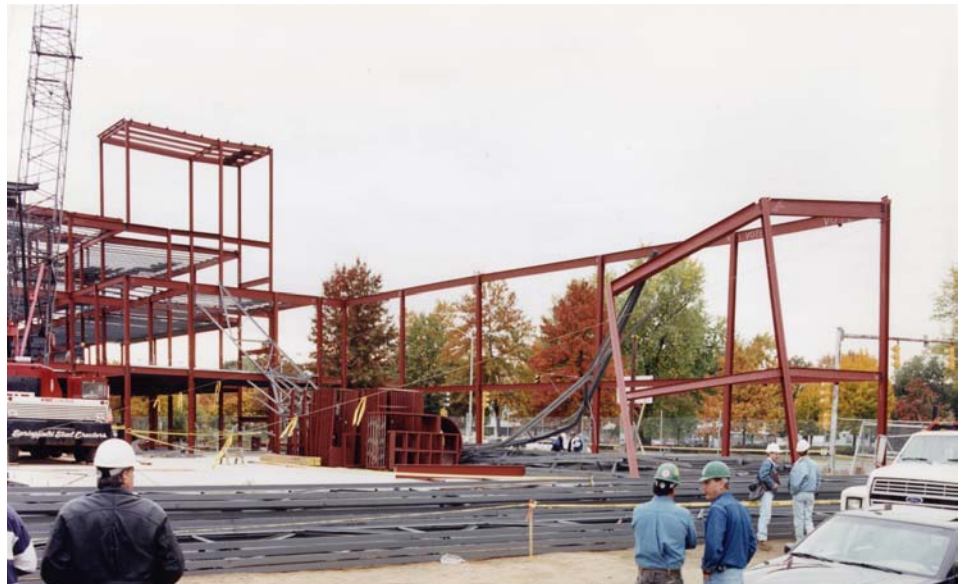
Figure 1 View of collapse taken the same day, looking southwest.

LS-7 pulled LS-4, LS-3, and LS-2 down with them and buckled LS-1 to complete the collapse. See Figures 6 to 11. LS-1 was hung up in the air in its buckled shape because it was bolted to the supporting girders; see Figures 6, 8, and 10. Due to its weight, LS-1 pulled over part of the framing on Line 65; see Figures 1, 6, and 10.

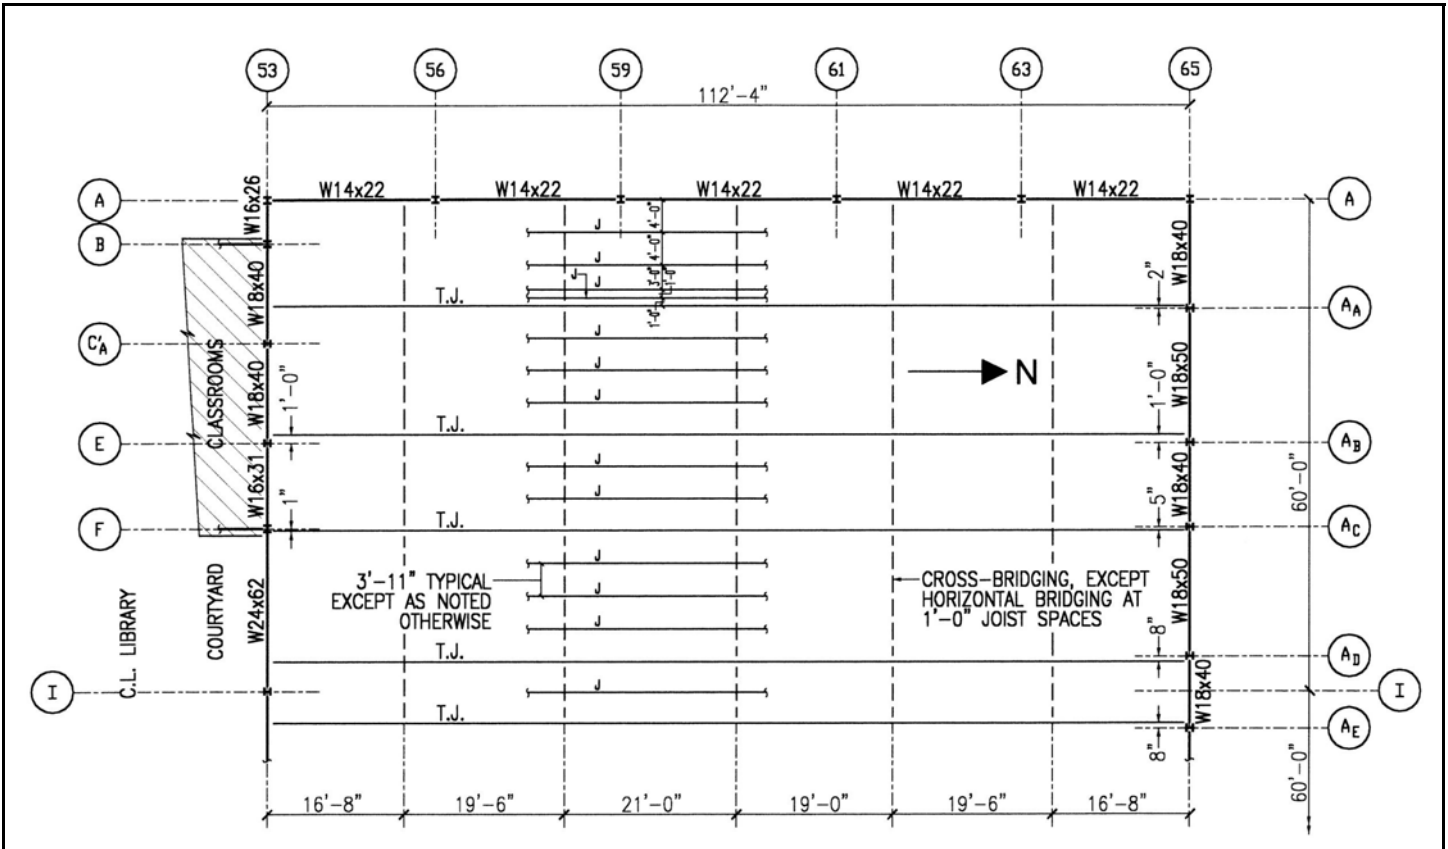
As shown on Figure 2, the typical joist spacing is 3'-11". The joists are braced against buckling during erection by 5 rows of cross-bracing, called cross-bridging, in which the top of a joist is braced to the bottom of the adjacent joists and the bottom of the joist is braced to the top of the adjacent joists. See Figure 3. The columns are irregularly spaced and the columns on Line 53 do not line up with the columns on Line 65. Normally, tie joists are located on the column centerlines and are supported by and bolted to a cap plate or seat angle on the columns. Tie joists prevent relative movement between lines of columns, and are necessary for safe erection. In this case, however, the tie joists are not at the column centerlines but are supported on and bolted to the tops of the steel girders along Lines 53 and 65.

Figure 2 Roof framing plan at west side of the library building. The east side is symmetrical about Line I. An adjoining 2-story classroom building is connected to the library building along Line 53. All joists are 60 DLH15s; T.J. means a tie joist bolted to the support framing; J means a joist welded to the support framing.

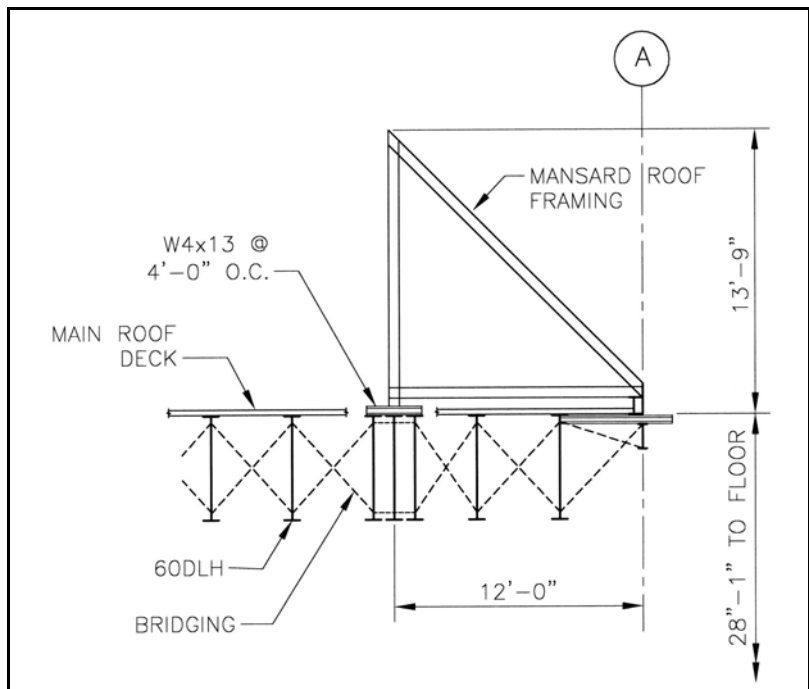
in Figure 3. The close spacing of the ganged joists precluded the use of cross-bridging; horizontal bridging (horizontal links) are substituted for the cross-bridging at the top and bottom of the joists.

Figure 3 Schematic section through mansard roof. The mansard roof is an architectural feature at the edges of the main roof, all around the entire building.

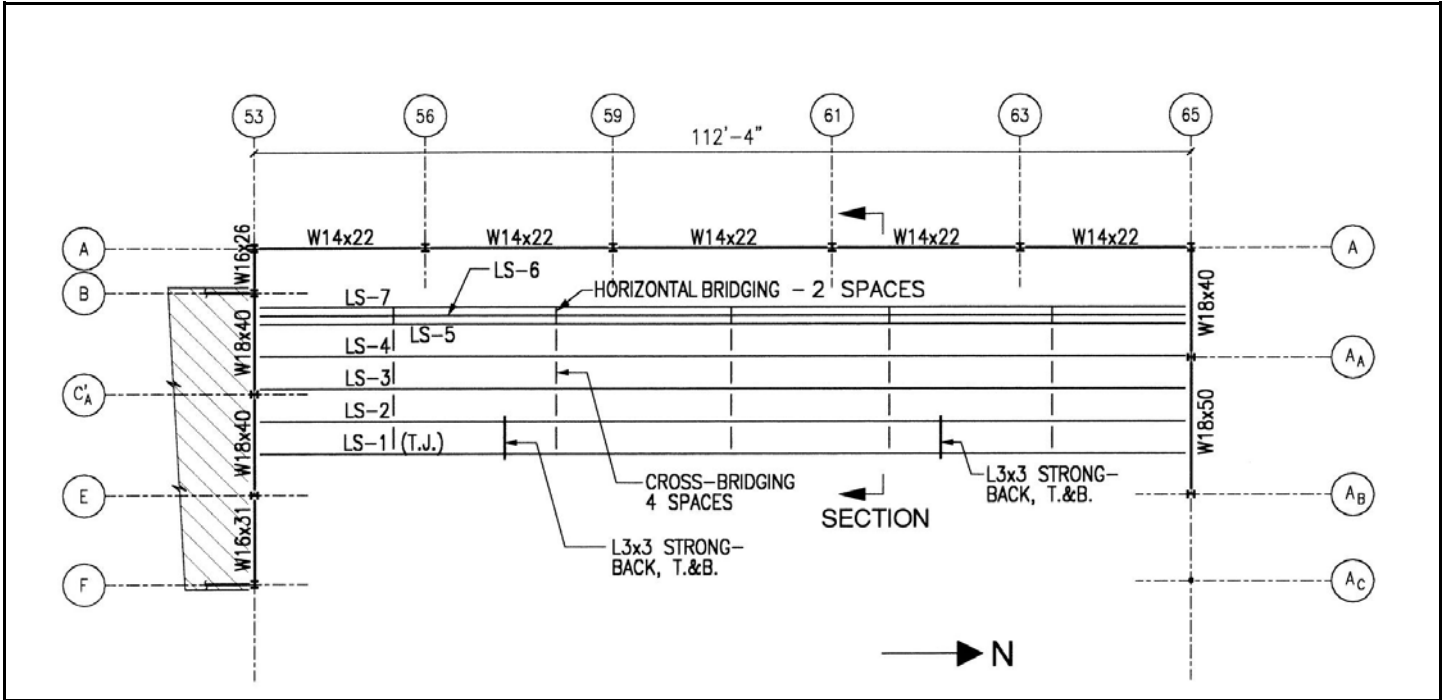
Figure 4 (on page 3) is a plan of the steel framing of the library roof that was erected in place before the collapse. Figure 5 is a section through this framing. There were 7 joists in place, along with 4 bays of cross-bridging and 2 bays of horizontal bridging along each bridging row. In addition, the erector had added 3"x3" angle strong backs so he could erect the first two joists, two welded to the top chord and two welded to the bottom chord.

Figure 4 Steel erected before the collapse. Joist numbers are those assigned by OSHA during its investigation. For section, see Figure 5.

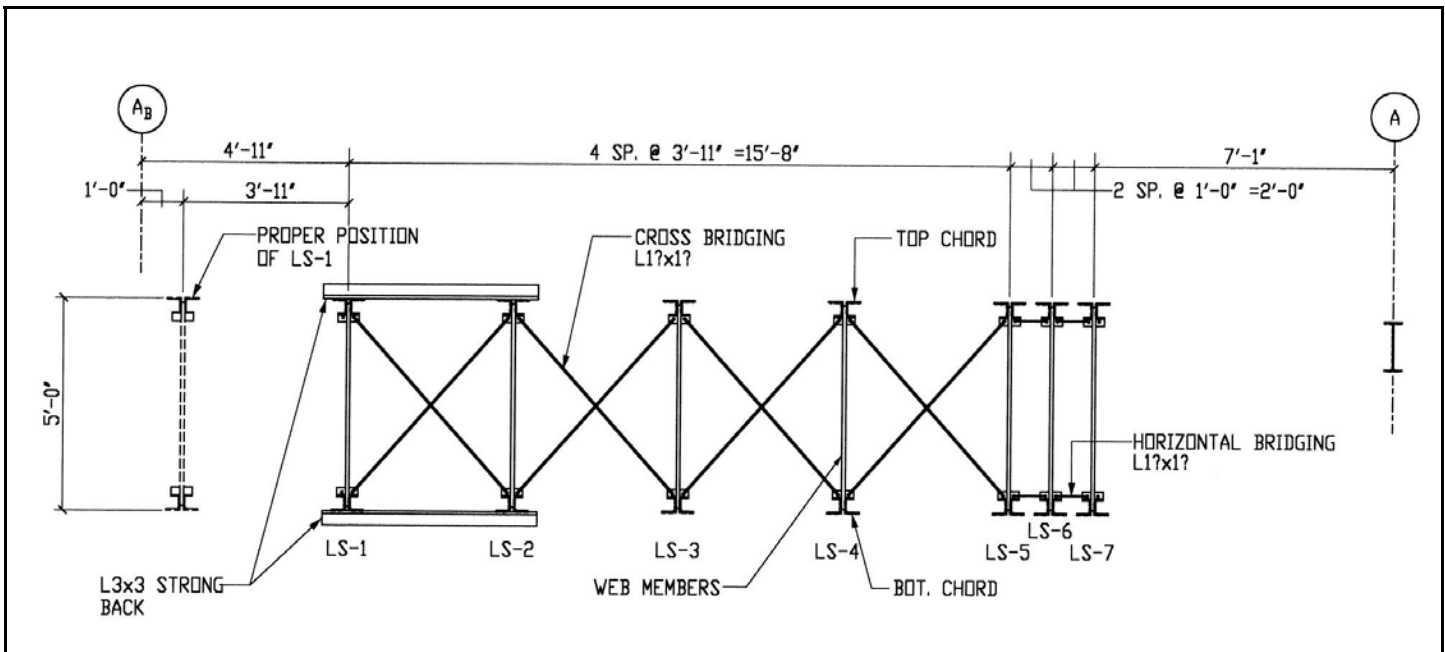
Figure 5 Section through steel erected before the collapse.

As shown on Figure 5, LS-1 was not installed in its proper position. It should have been installed a joist space (3'-11") to the left. The structural steel shop drawings did not show holes in the top flanges of the girders along Lines 53 and 65 for the tie joists, and the beams were fabricated without the holes. The erection superintendent noticed that there were no holes in the top flanges of the girders on Line 53 when he erected them with the adjoining classroom building; however, he did not so inform either the general contractor or the fabricator. When the time came to erect the deep longspan joists for the library building, he drilled holes in the top flanges of the girders for the first tie joist (LS-1). Unexplainably, he drilled these holes at the wrong location. When LS-7 was erected in place, the erection superintendent saw that he had space for only one joist rather than the two that were supposed to be erected after LS-7 (see Figure 3), and realized that he had made an error.

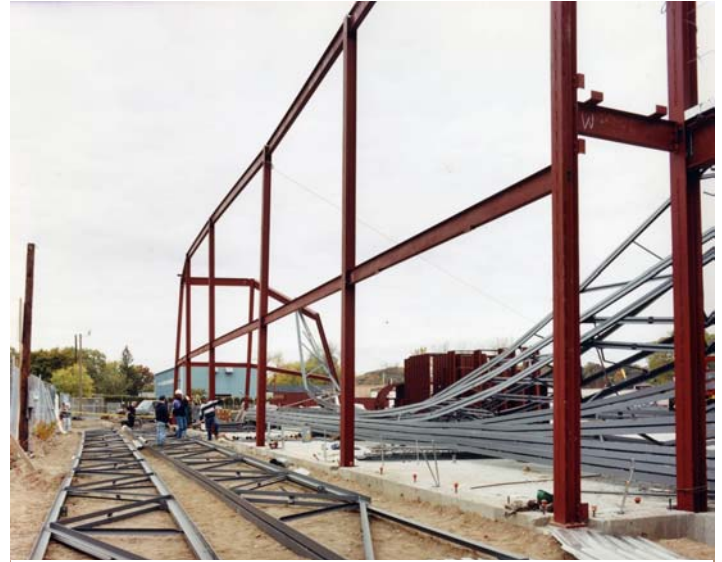
Figure 6 View of collapse looking in a northeast direction from a point near Column A-53.

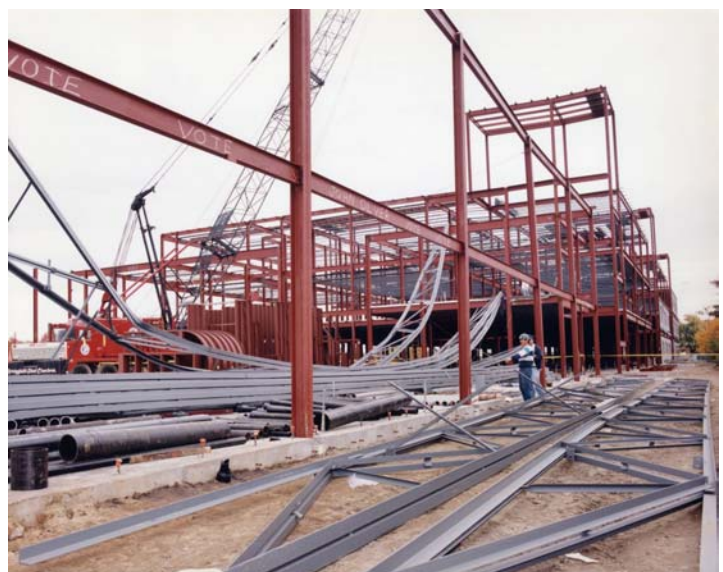
Figure 7 View of collapse looking southeast. Framing running from left foreground to the right background is Line A.

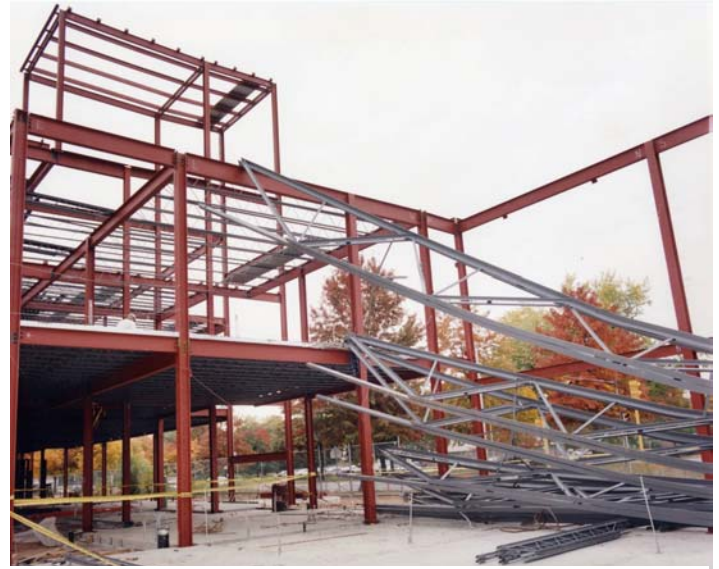
Figure 8 South end of collapsed joists. The Line 53 steel runs from the left to the right; The Line A steel is on the right. LS-1 is hung up on the roof girder; LS-2 and LS-3 are hung up on the 2nd floor of the classroom building.

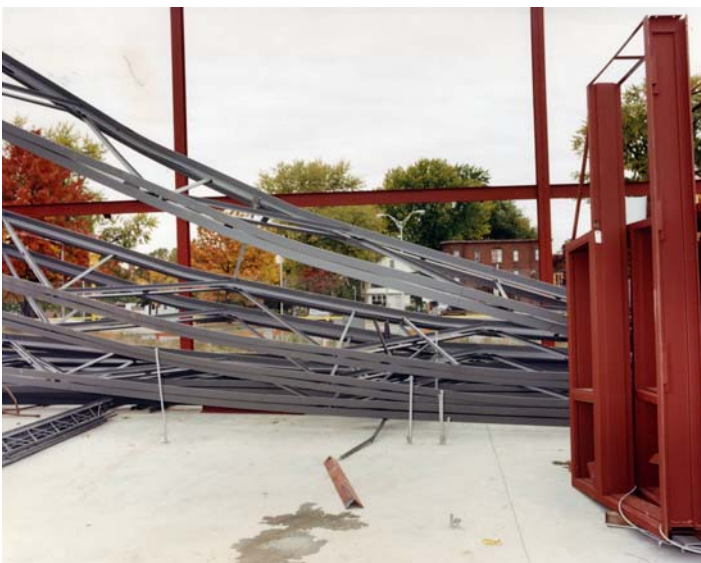
Figure 9 View of joists to the right of that shown in Figure 8. The angle on the ground is one of the strong backs.

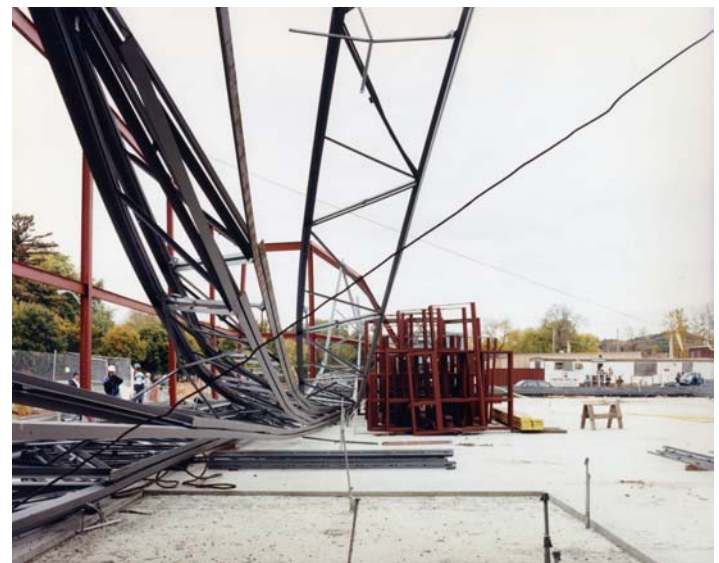
Figure 10 View under joists looking north. LS-1 is hung up in the air on the right. The near ends of LS-2 and LS-3 were also hung up in the air.

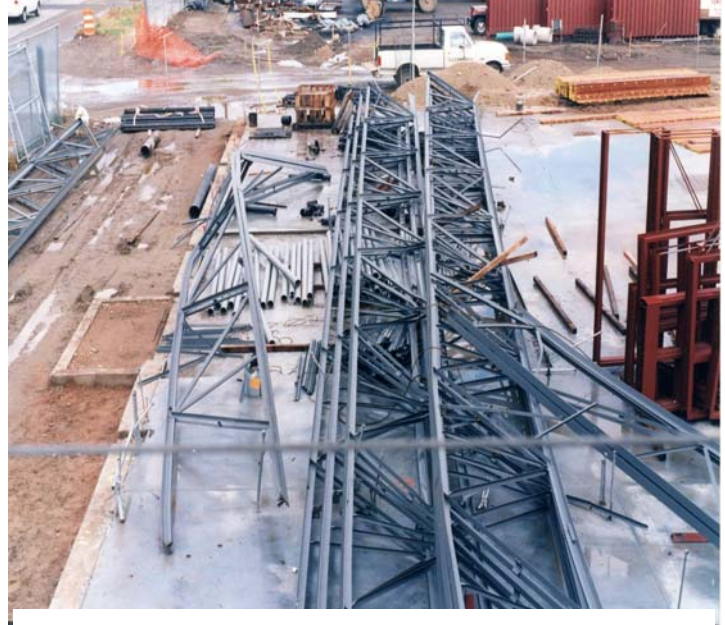
As shown in Figure 11, LS-5, LS-6, and LS-7 fell together in one pile closest to Line A (the left pile in Figure 11). LS-2, LS-3, and LS-4 fell in another pile (the pile on the right in Figure 11).

Figure 11 View of collapse from 2nd floor of classroom building, looking north, after the joists that were hung up on the framing were cut down, and after the framing on Line A and Line 65 was dismantled. The north half of LS-1 is on the left; the south half of LS-1 is lying across the right pile.
