Investigation of a Stone Arch Bridge

The stone arch bridge is located on Winter Street in Framingham, MA, where it crosses the Sudbury River. The bridge is part of a causeway connecting the high ground on both sides of the Sudbury River. The bridge and causeway were built in the 1700s. The causeway consists of two dry stone masonry retaining walls with fill between them. Where the causeway crossed the original river channel, a two-span dry stone masonry arch bridge was constructed. In 1971 a separate foot bridge was erected close to the downstream side of the cause-

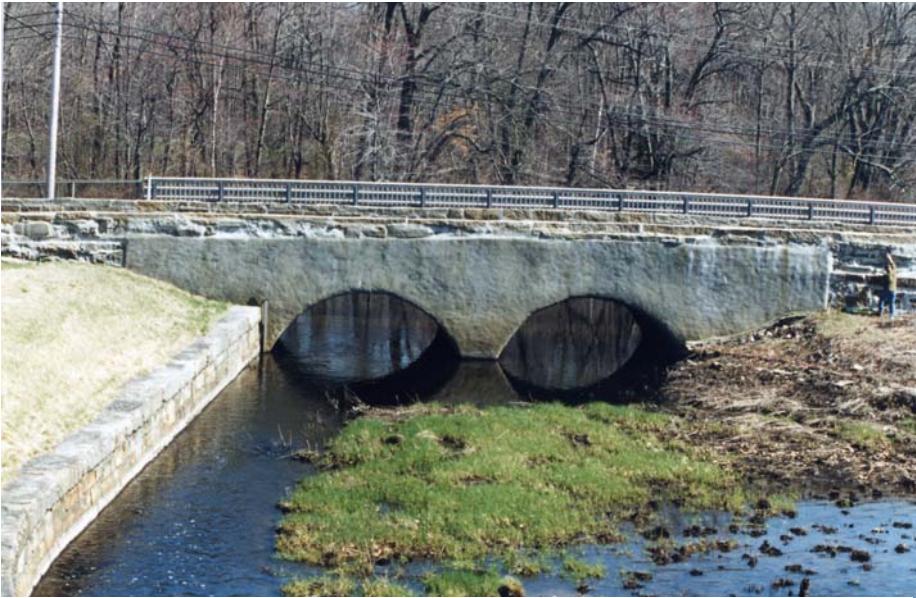
Figure 1. Upstream view of the Winter Street Bridge over the Sudbury River. Bridge built in 1700s. 1995 photo. Causeway extends from both ends of the bridge. Stone wall and banking in left foreground added in the 1870s.

Figure 1 is a photo of the upstream side of the bridge as it existed in 1995. Figure 2 (*page 2*) is a photo of the downstream side. Figure 3 shows the underside of one of the arch barrels. Figures 4, 5, and 6 (*page 3*) show a plan, a longitudinal cross-section, and a transverse cross-section of the bridge.

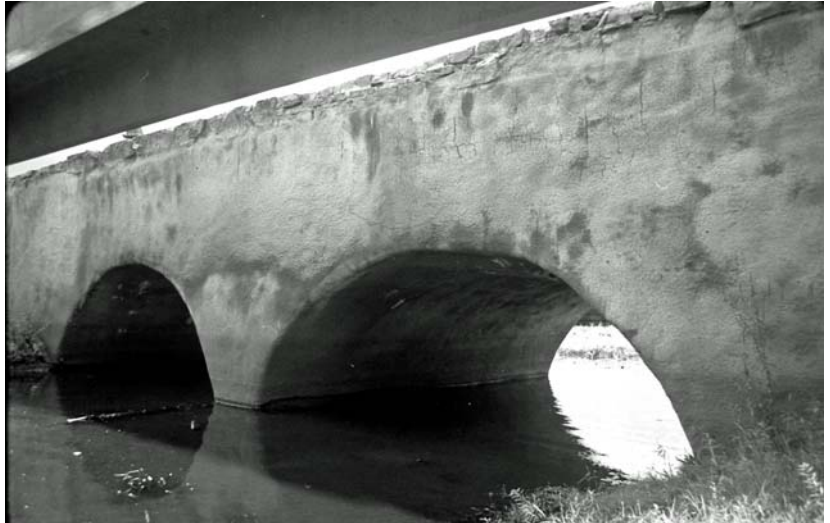
Figure 2. Downstream side of the Winter Street Bridge as it appeared in 1977. The bottom of the footbridge can be seen in the upper left foreground.

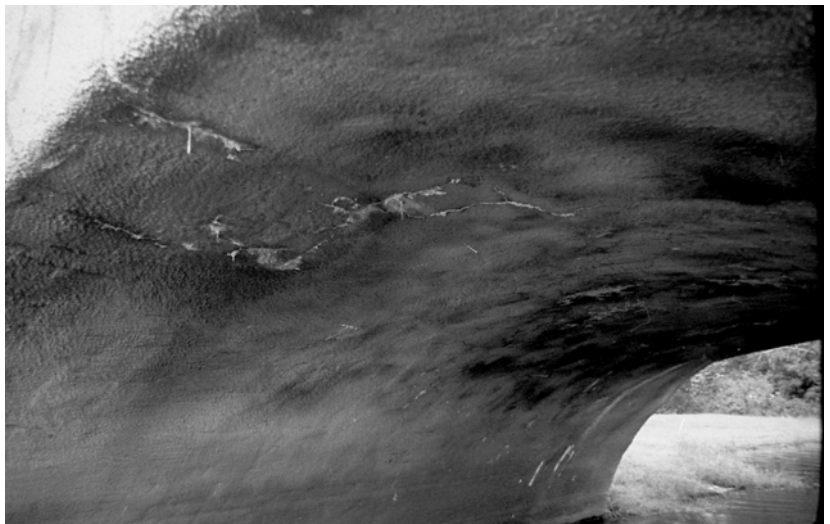
Figure 3. View of bottom of one of the arch barrels. 1977 photo.

way, and at that time the dry stone masonry arches of the bridge were pressure grouted and the exposed surfaces of the arch barrels and spandrel walls were gunited.¹

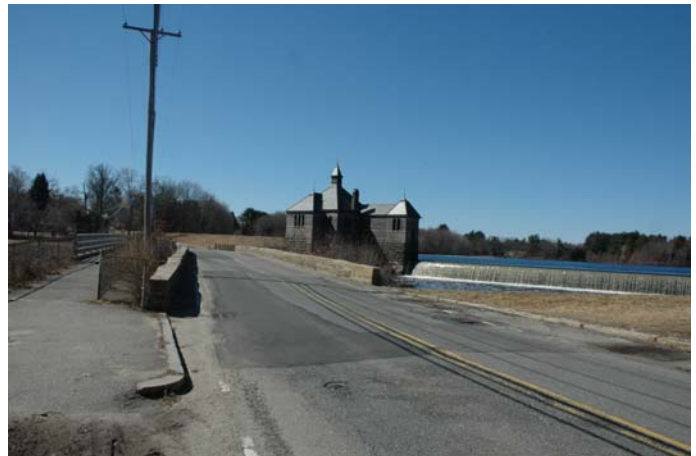
Photo 7. Causeway looking south. Stone arch bridge is on the near end of the causeway. The dam is to the right and the footbridge is to the left.

The original causeway and bridge were built in the early 1700s . The arches were built of dry stone (i.e. no mortar was used), and the spandrel walls of the bridge (the side walls) and the retaining walls of the causeway were also built of dry stone. The top of the arches, and the causeway, were filled with soil up to the road surface. There was no paving. Photo 7 shows what the roadway looks like today (2008).

In 1877, the Boston Water Works Commission constructed a dam across the Sudbury River, just west and upstream of the causeway, and constructed an underground aqueduct just south of the south end of the causeway. See Photos 7 and 8. The dam is known as Dam No. 1, and is one of three dams built to create reservoirs for water for the City of Boston. The aqueduct is known as the Sudbury Aqueduct.

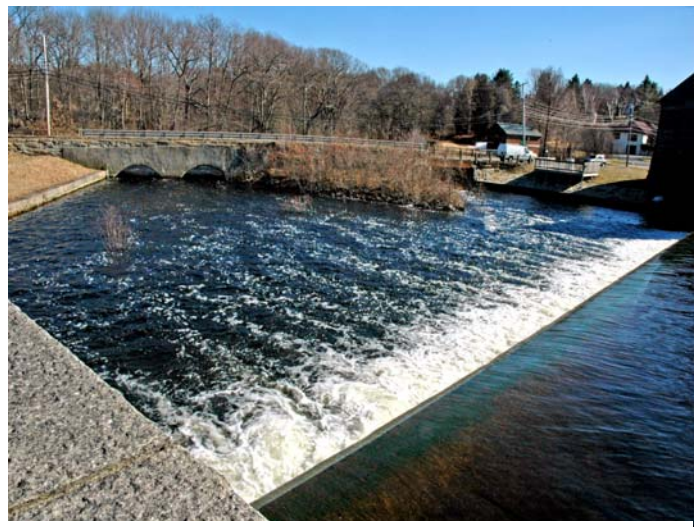
Photo 8. View of causeway looking east from top of spillway of dam. The bridge at the south end of the causeway can be seen in the right background.

When the dam was built, a new river channel and bridge was cut through the causeway near the south end. See Photo 8.
