Shoring a Precast Concrete Parking Garage

A Photo Essay

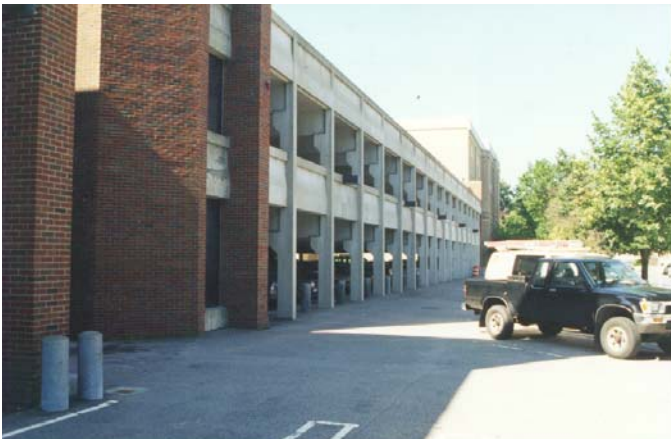
The garage has three levels, one on the ground and two framed levels. There is a separate cast-in-place concrete ramp structure in the rear.

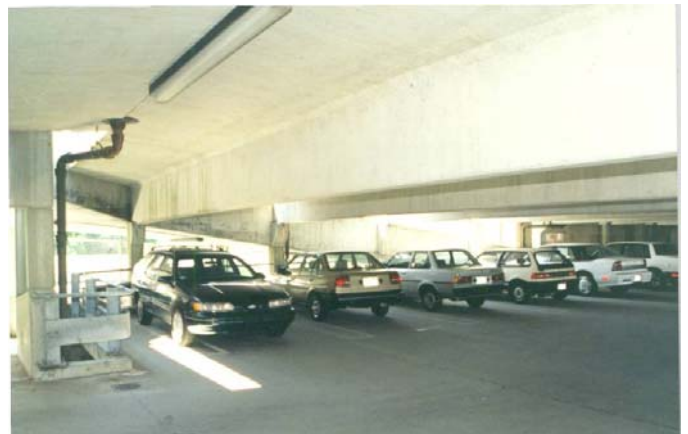
The garage framing consists of precast concrete "single tees," 11'-5" wide by 3'-4" deep, spanning 65 feet, with the stem of each tee being supported on a precast concrete column on the exterior, and on a cast-in-place concrete column on the interior. There is a 6 inch concrete topping over the tees.

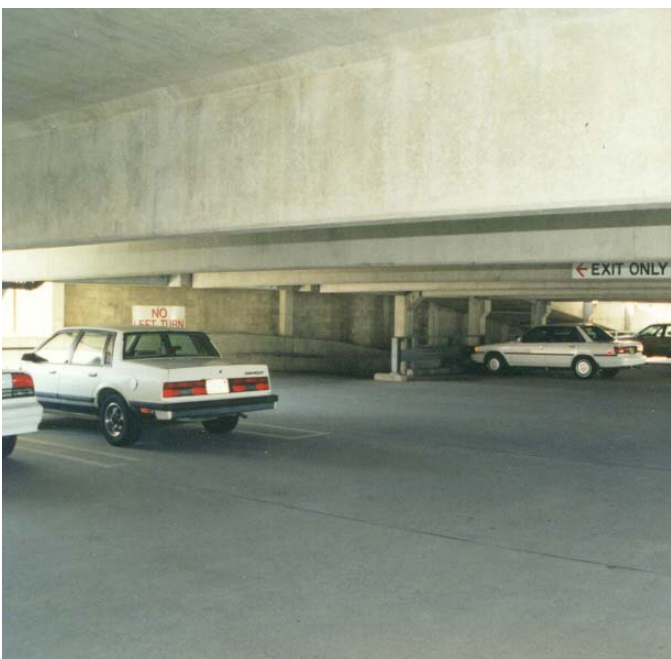
At the accesses to the ramp structure, the single tees are supported on cast-in-place concrete girders. Each girder has two brackets with each bracket supporting a single tee. The bottom of the girder is flush with the bottom of the single tees.

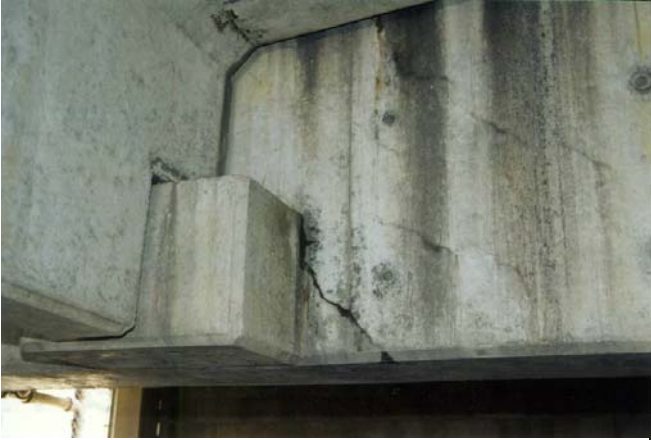
As the photo shows, the ends of the single tees are dapped at the girders, and are supported on reinforced concrete brackets that project from the girders and were cast integrally with the girders. The vertical load from the end of the single tee tries to twist the bracket off of the beam. This action is normally resisted by reinforcing steel in the bracket and girder; however, vertical hoop reinforcing (closed stirrups) in the girder, which would resist this action, was omitted from the design and the construction, causing the cracks shown.

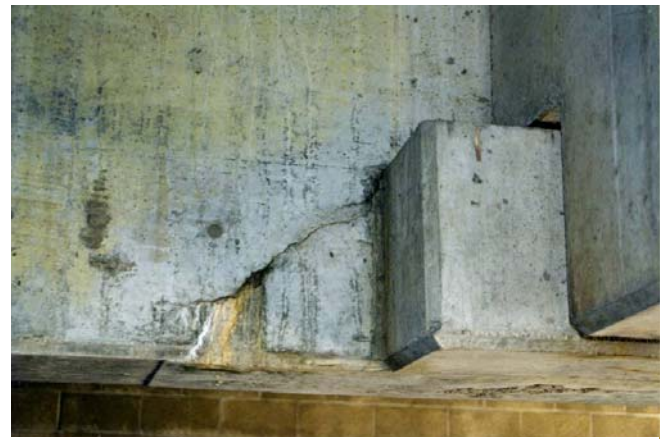
Another view of the cracking. The single tee is on the right of the photo. Zallen Engineering investigated this problem and recommended that the garage be shored near the brackets. This recommendation was accepted and Zallen Engineering designed the shoring system.

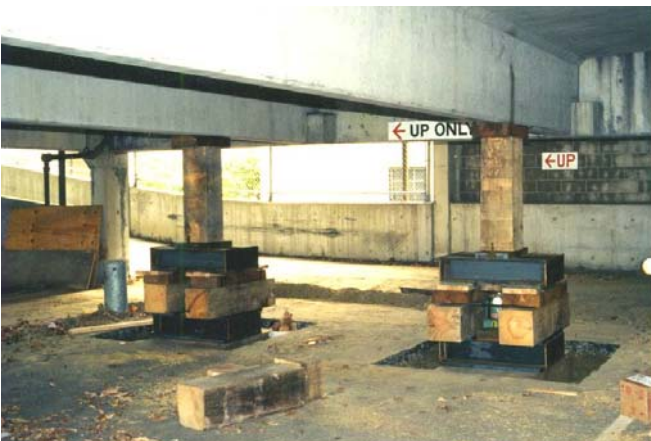
The shoring supported the stems of the second and third floor single tees near the girder brackets. This photo shows the shoring on the first floor at the access to the up ramp. There was additional shoring above on the 2nd floor supporting the third level single tees.

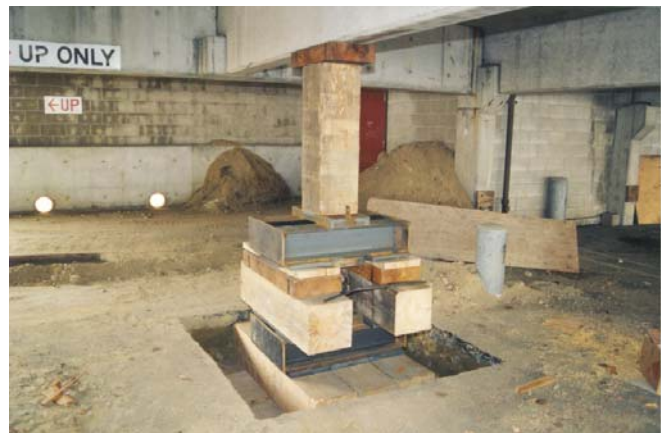
From top to bottom, there is an oak pad between the stem of the single tee and a 12" x 12" Southern Pine shore, then a steel fixture which spreads the load to oak wedges, then timber spacers, then a bottom steel fixture which spreads the load to timber cribbing. The cribbing is below the ground surface due to the proximity of large column footings.

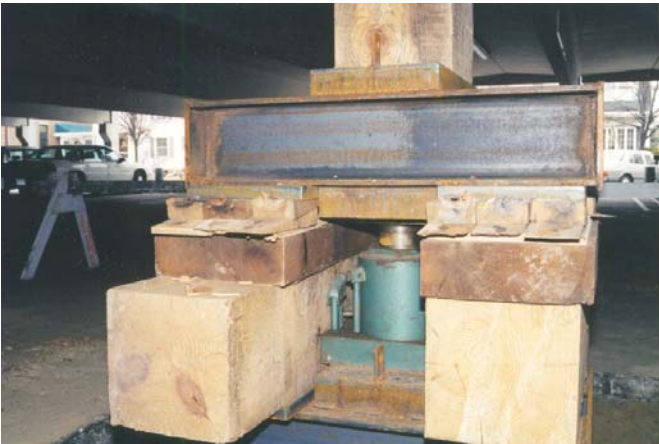
This photo shows a close-up of the wedges, and the jack that was used to lift the single tees. When the jack lifted the steel fixture and the single tee, transferring load into the shoring system, the wedges were driven into the space between the steel fixture and the timber spacers.

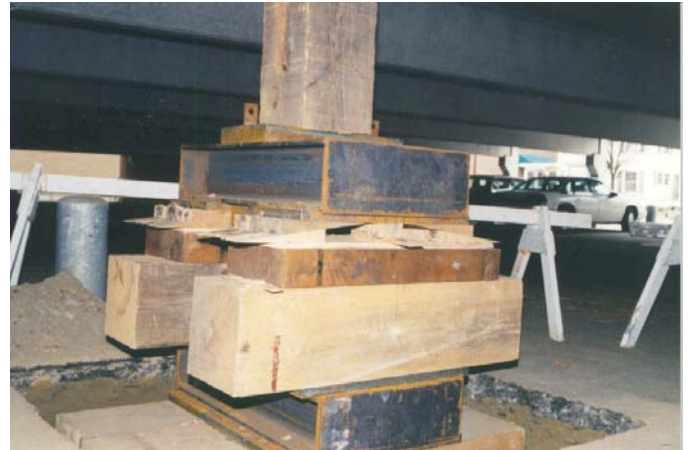
Another close-up view of the shoring.

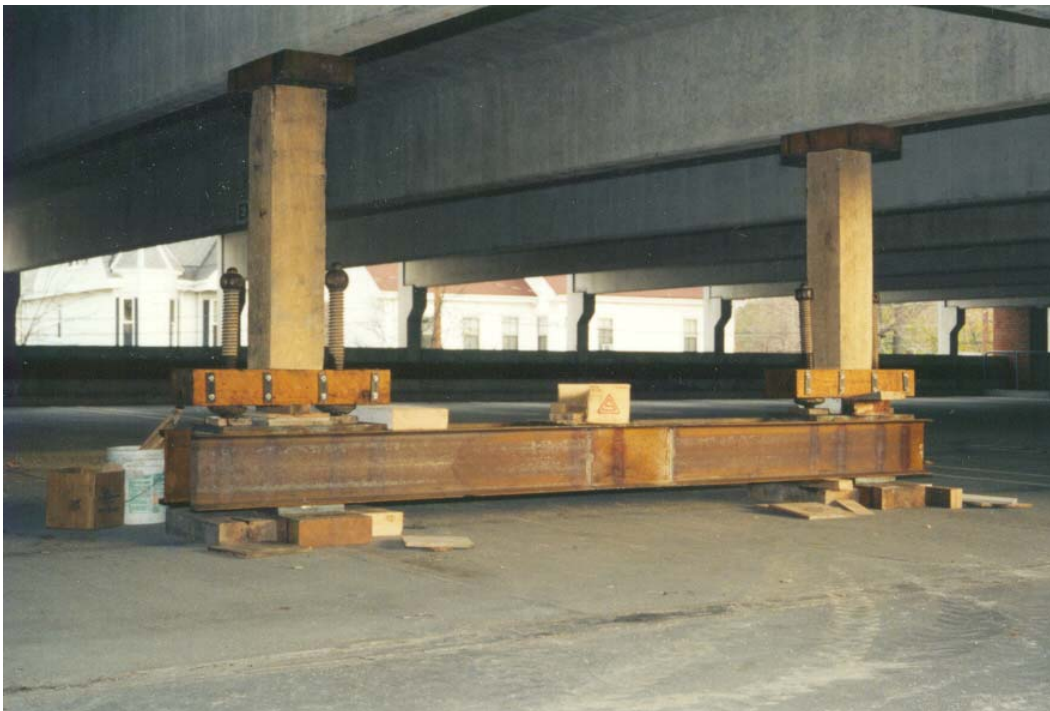
This photo shows the system used on the second floor. The oak beams with the screw jacks transfer load from the third level single tees to a steel beam consisting of two spaced channels. The center of the stems of the single tees of the third floor do not line up with the center of the stems of the single tees of the second floor. The beam prevents eccentric load on the shores below.

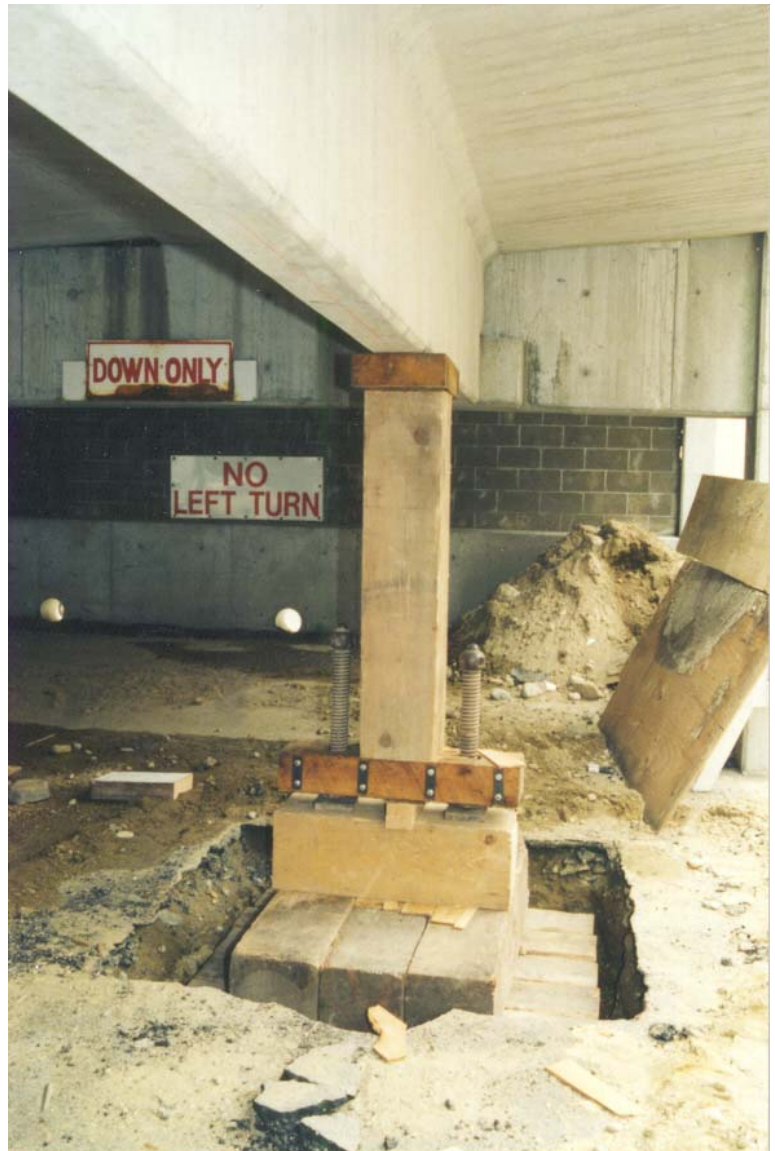
A different style of shoring was used at a location where the span of the single tees are relatively short and the load is lighter. The shore is supported by an oak beam with cast-steel inserts engaging a pair of screw jacks. As the jacks were turned to lift the load (the jack handles are not shown), wood wedges were driven below the oak beam to support the load.
