Investigation of Fire-Damaged Warehouse

A fire occurred in a moving company warehouse in New England in 1998. The owner of the building retained Zallen Engineering to determine the structural safety of the building as a result of the fire and the necessary repairs. The warehouse is 153 feet long by 99 feet wide, was constructed in 1962, and is of metal building construction.

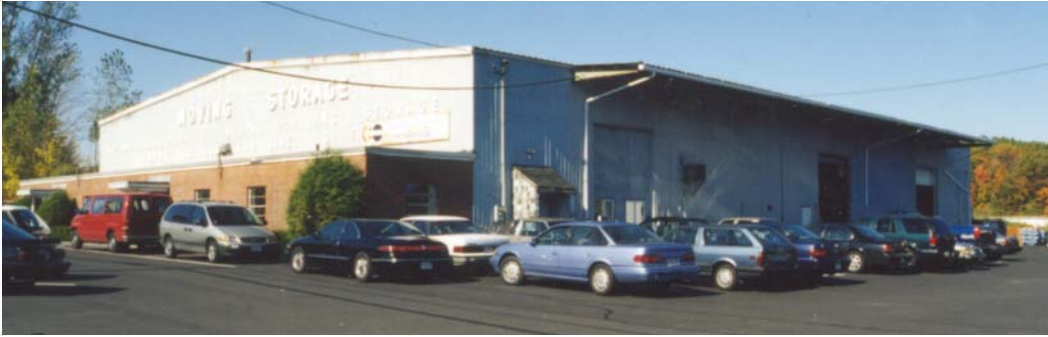
Figure 1. View of south and east sides of moving company warehouse.

Figure 1 shows a photo of the south end, which is the front of the building, and the east side of the building which contain the overhead loading doors. The front low roof section of the building contains offices and was not damaged by the fire.

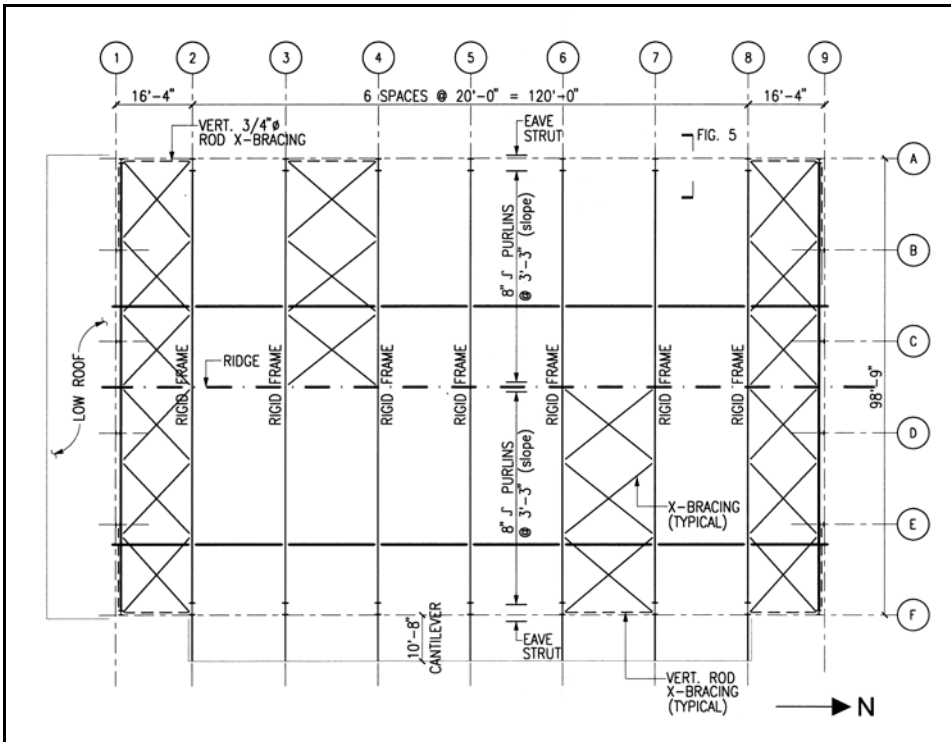
Figure 2. Plan of roof framing.

Figure 2 (*next page*) is a plan of the roof framing. The principal support system of the building is composed of 7 rigid frames¹ on Lines 2 through 8, spanning the full width of the building. Figures 3 and 4 are photos of part of the rigid frame on Line 8; Figure 5 (*page 3*) shows construction details at the eaves and defines the various structural elements. The end wall supports on Lines 1 and 9 consist of roof beams and columns; see Figure 2. Figure 4 shows part of this framing on Line 9, in the background. The roofing consists of 19 gage cold-formed corrugated steel sheets supported by 8 inch deep, 14 gage cold-formed steel purlins of “Z” shape. The purlins run across the top of and are sup-
